Marantz PM7200 repair

During the last RepairCafe I got a Marantz PM7200 amplifier in my hands that had a very interesting fault.

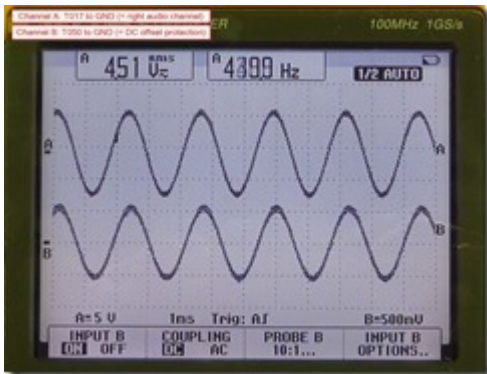
I fed a sine wave (440 Hz, 500 mVpp) to the right and left channel (0° phase shift). I increased the volume so that the error just show up. When I measured the signal (T050 to GND) I saw the same signal shape as at the output stage (T017 to GND). The measurement is shown at the screenshot below. The test points are marked green in the schematic above.

The protection circuit has a TA7317P IC in it. If you look at the datasheet you see that the IC will send the amplifier to protection mode when a voltage level of approximately 1 V is exceeded. With this information it seems plausible that (given the signal at T050 as shown above) the amplifier switches to protection mode.
