# Marantz PM7200 repair

During the last RepairCafe I got a Marantz PM7200 amplifier in my hands that had a very interesting fault.

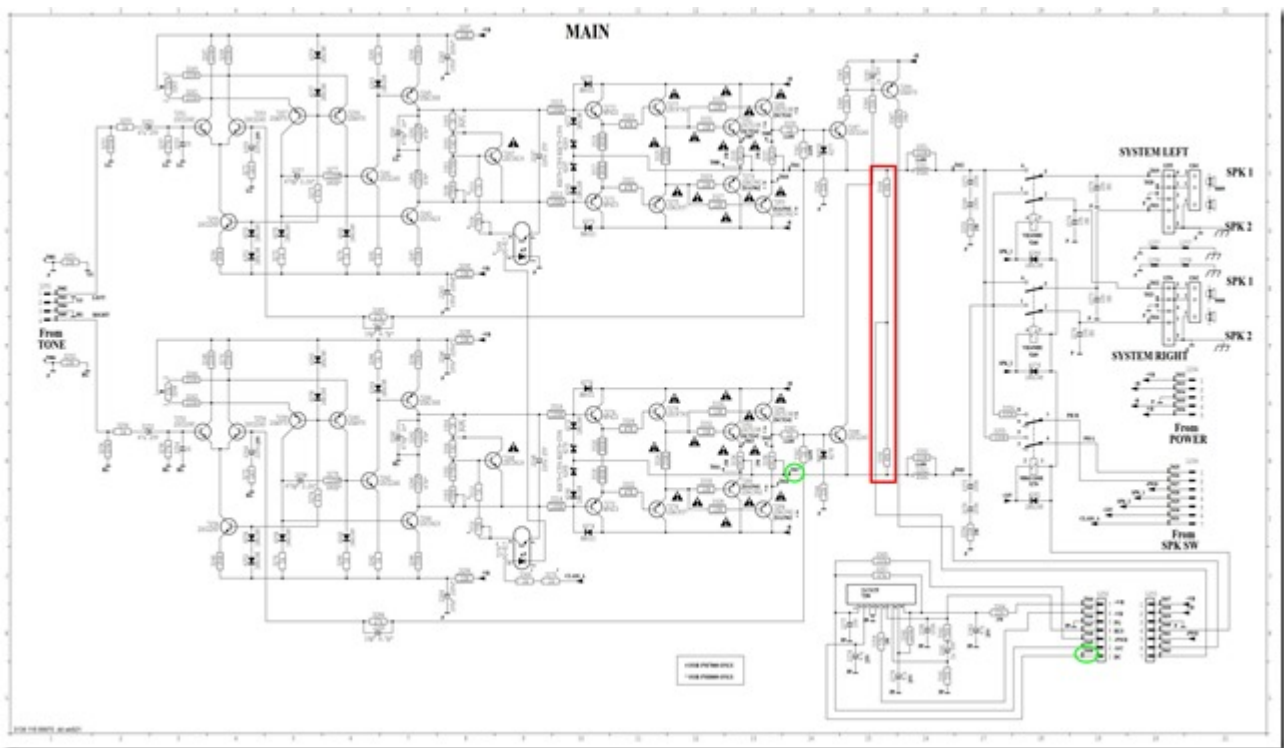
If you search on the internet, you can find a service manual which is really helpful because it has all the schematics in it. Because all the signals I measured so far seemed fine, I decided to investigate the protection circuit and measure the signals there. By studying the schematic of the main amplifier one can see, that at the end of the output stages the signal gets tapped of to the protection circuit (marked with the red

box). This signal is for DC offset detection.

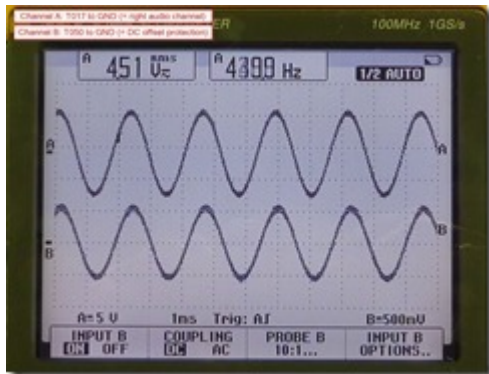
I fed a sine wave (440 Hz, 500 mVpp) to the right and left channel (0° phase shift). I increased the volume so that the error just show up. When I measured the signal (T050 to GND) I saw the same signal shape as at the output stage (T017 to GND). The measurement is shown at the screenshot below. The test points are marked green in the schematic above.

The protection circuit has a TA7317P IC in it. If you look at the datasheet you see that the IC will send the amplifier to protection mode when a voltage level of approximately 1 V is exceeded. With this information it seems plausible that (given the signal at T050 as shown above) the amplifier switches to protection mode.

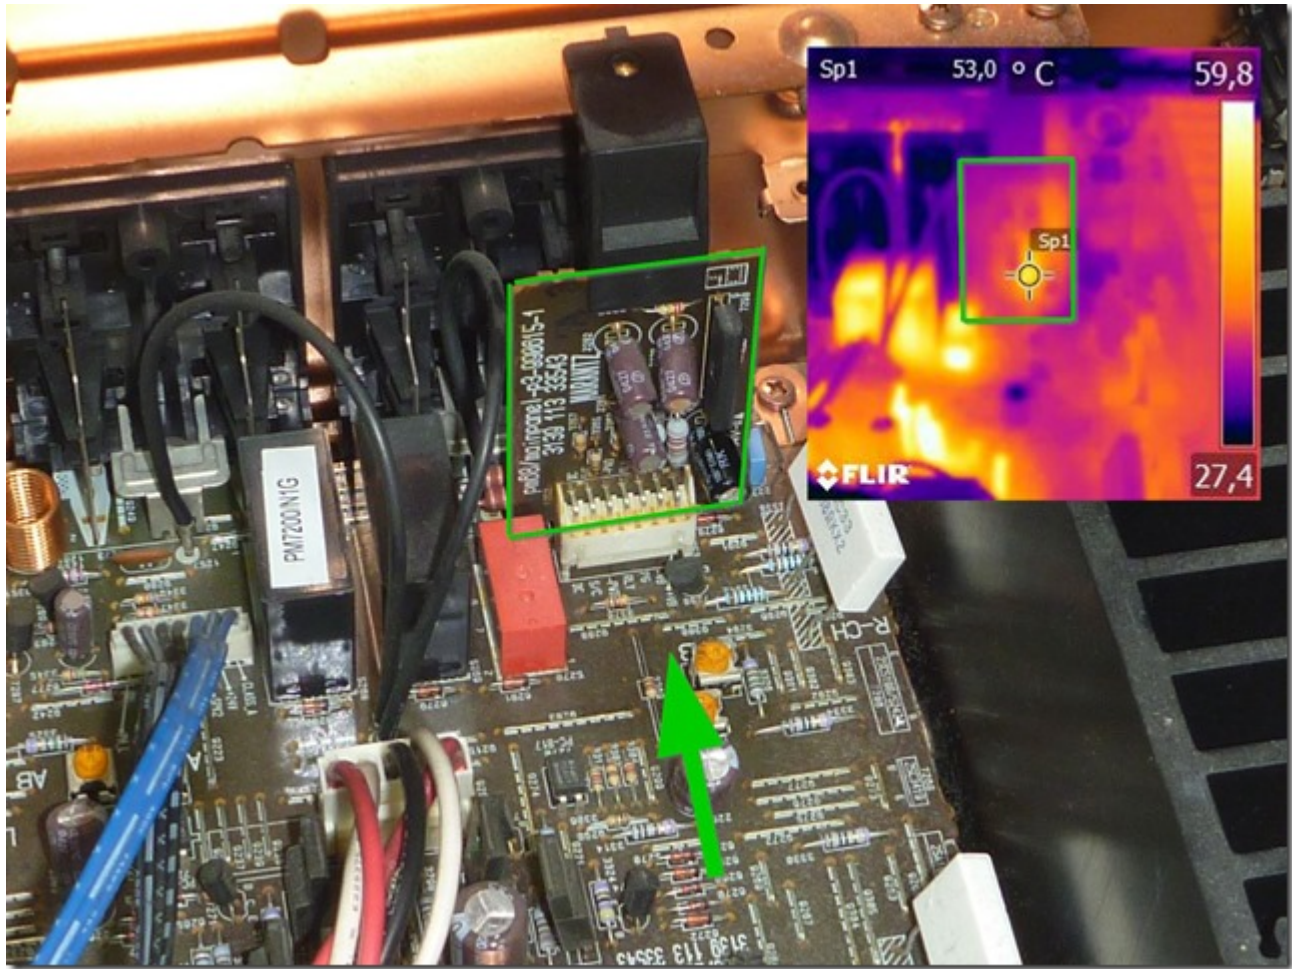
I did some thermal imaging of the protection circuit board. The picture above was taken after 5 minutes idle time of the amplifier (switched on but no signal). The green arrow indicates the approximate direction of the IR Image. The green frame marks the protection circuit board. As you can see there is a hotspot (53 °C) very close to the broken capacitor caused by two 1 W resistors (3364 and 3358). The permanent exposure to heat probably killed the capacitors.

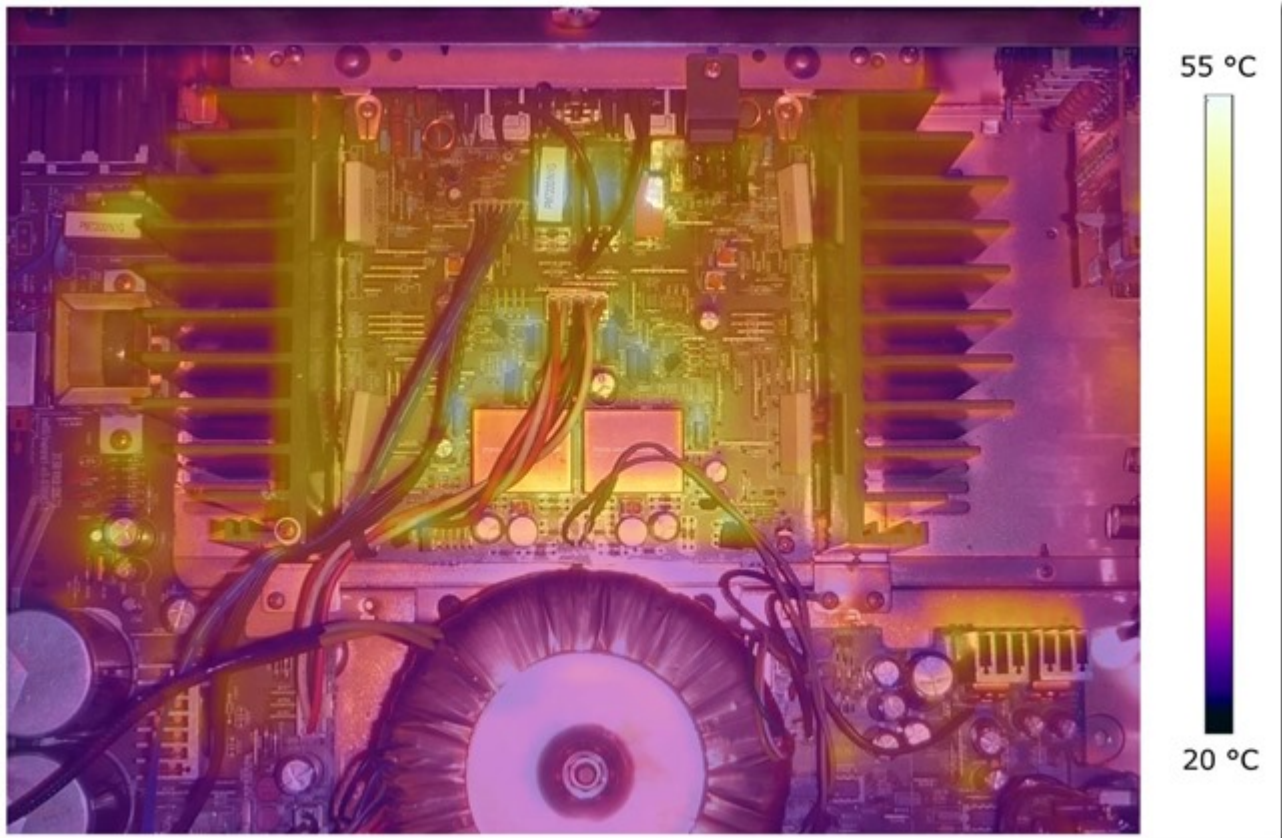
I also did a thermal image of the whole main amplifier board to find other hotspots. To recognize the components better, I made an overlay with a normal picture (I used gimp for that). The overlay is not perfect because of a slightly different angle and focal length of the two cameras. You can see that there are areas that get 55 °C hot if the amplifier is idle (the picture was taken after 10 minutes idle time). In the center area there are some linear regulators that have capacitors close by. I measured some of those capacitors and all seem to have degraded so I went ahead and replaced the ones that were close to heat sources (2264, 2263, 2256, 2255, 2268, 2267).
