Marantz PM7200 repair

During the last RepairCafe I got a Marantz PM7200 amplifier in my hands that had a very interesting fault.

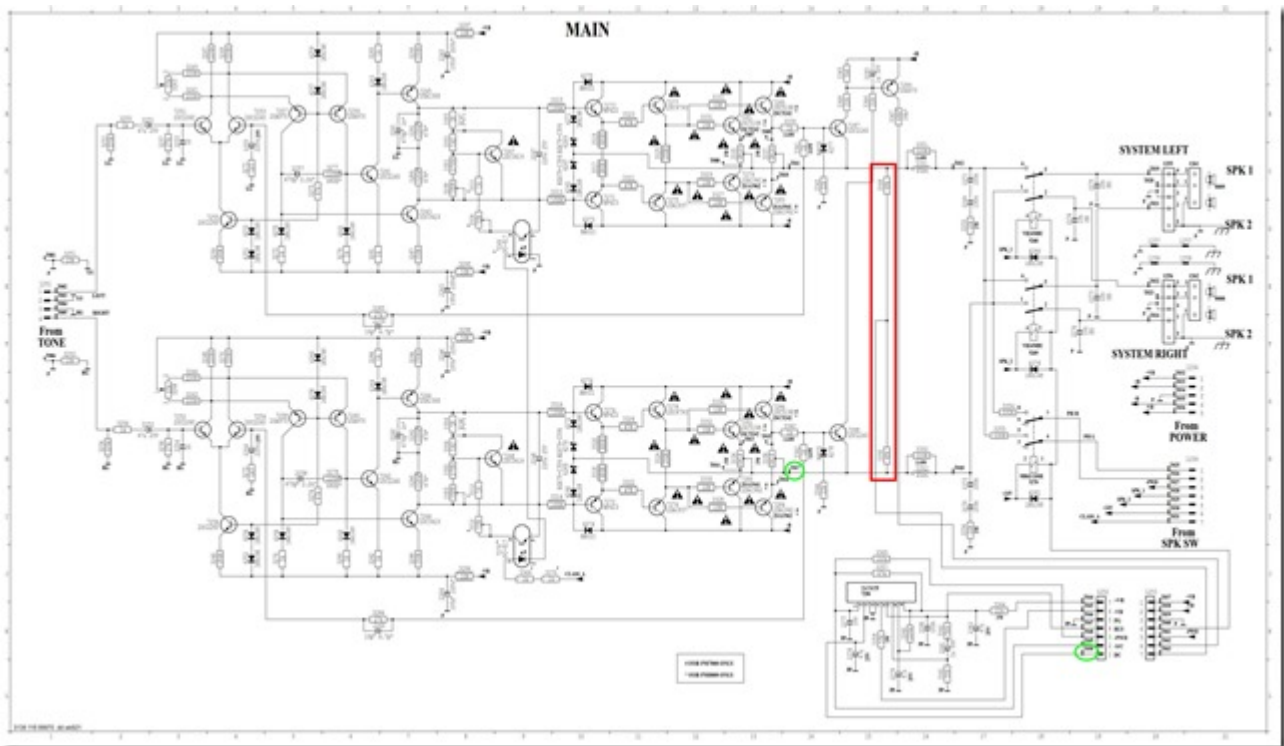
If you search on the internet, you can find a service manual which is really helpful because it has all the schematics in it. Because all the signals I measured so far seemed fine, I decided to investigate the protection circuit and measure the signals there. By studying the schematic of the main amplifier one can see, that at the end of the output stages the signal gets tapped of to the protection circuit (marked with the red

box). This signal is for DC offset detection.
