Marantz PM7200 repair

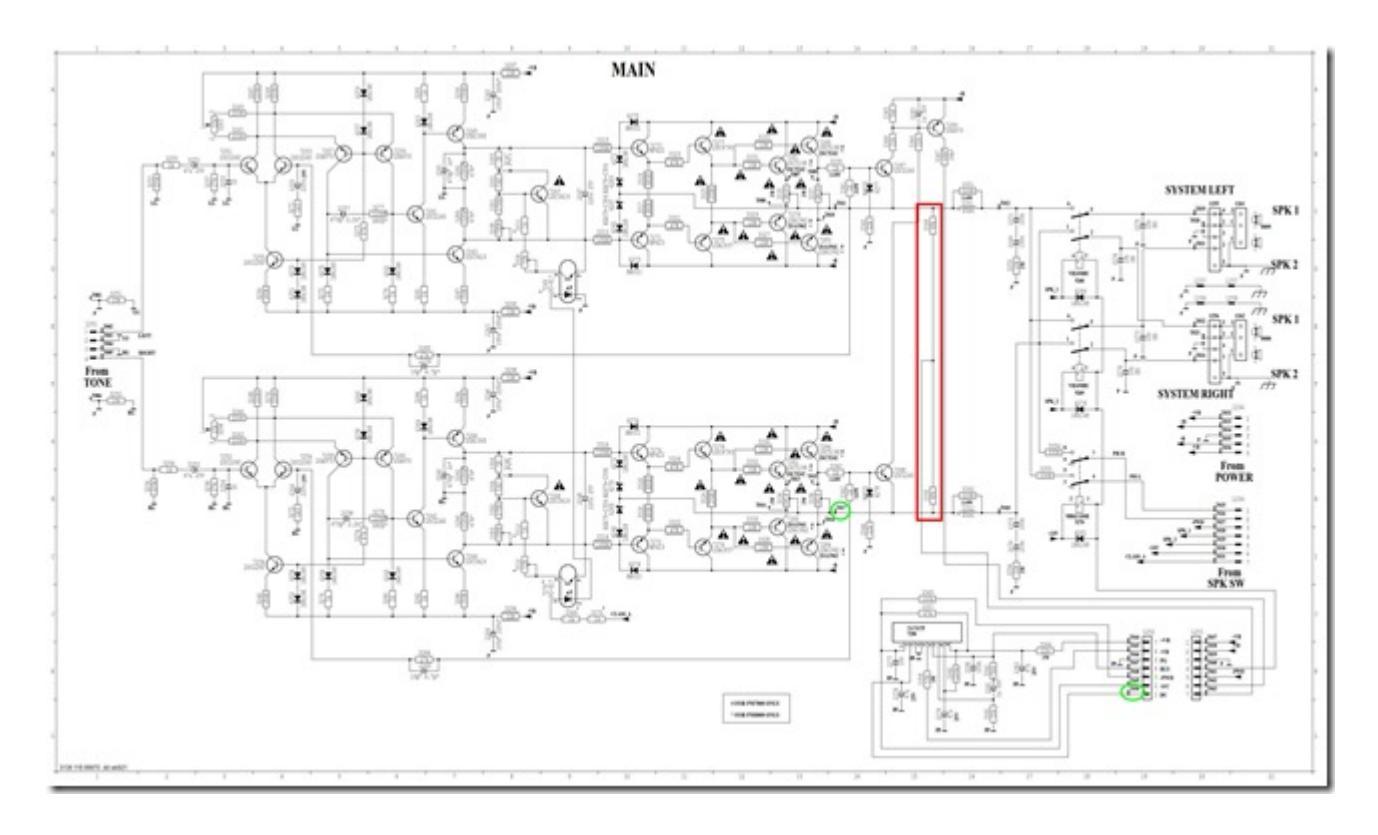
If you search on the internet, you can find a service manual which is really helpful because it has all the schematics in it. Because all the signals I measured so far seemed fine, I decided to investigate the protection circuit and measure the signals there. By studying the schematic of the main amplifier one can see, that at the end of the output stages the signal gets tapped of to the protection circuit (marked with the red box). This signal is for DC offset detection.

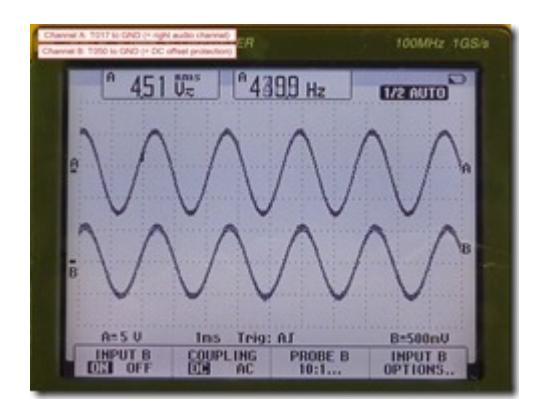
I fed a sine wave (440 Hz, 500 mVpp) to the right and left channel (0° phase shift). I increased the volume so that the error just show up. When I measured the signal (T050 to GND) I saw the same signal shape as at the output stage (T017 to GND). The measurement is shown at the screenshot below. The test points are marked green in the schematic above.

The protection circuit has a TA7317P IC in it. If you look at the datasheet you see that the IC will send the amplifier to protection mode when a voltage level of approximately 1 V is exceeded. With this information it seems plausible that (given the signal at T050 as shown above) the amplifier switches to protection mode.

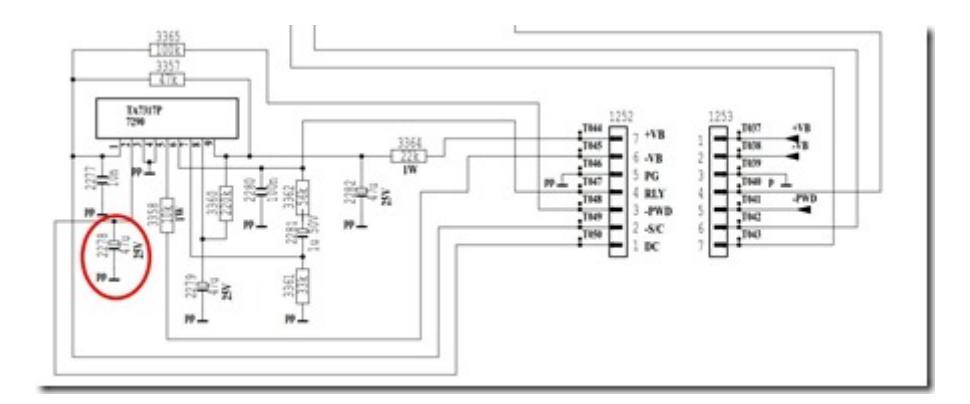
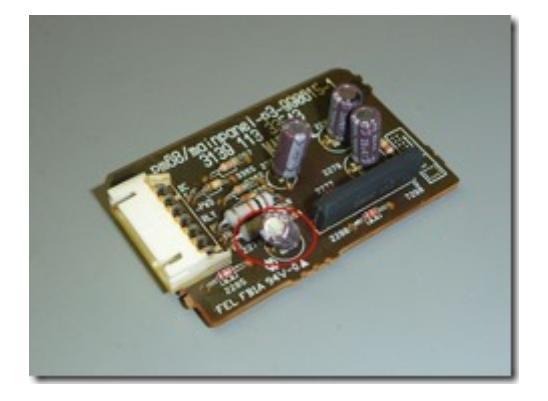
My next test was to fed in the same signal as before (440 Hz, 500mVpp) but this time I shifted the phase of the left channel by 180°. My thought was, that with the phase shifted input signal, there should be no signal at T050 (left and right signal cancel each other out). With the so fed signal the amplifier didn't show the error anymore! This led me to the conclusion that the amplifier is probably working fine and just the protection circuit has a defect.

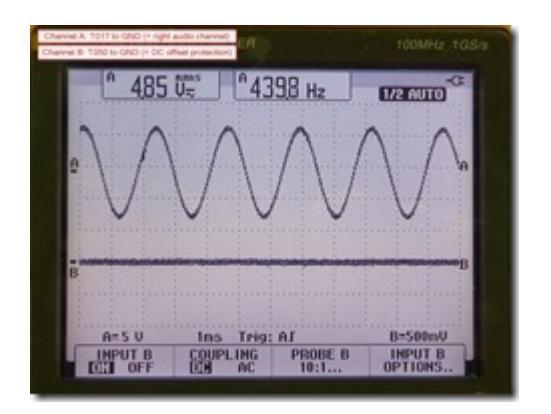
Some further investigation showed, that there is a capacitor (2278) attached to the DC offset line that should flatten all the AC signals. When I measured the capacitor with the LCR-Meter there was no reading of the capacitance possible (the capacitor was dead). I replaced the capacitor with a new one with the same values (I used a 105 °C rated) and did the first measurement (with 0° phase shift) once more.

As to be expected the signal at T050 changed drastically. All the AC part was gone and the amplifier didn't turn off anymore! Yeah ... problem found and fixed! To be safe I replaced all four electrolytic capacitors (2278, 2281, 2282, 2279) on the protection board. I measured them later on and they all where in pretty bad condition.

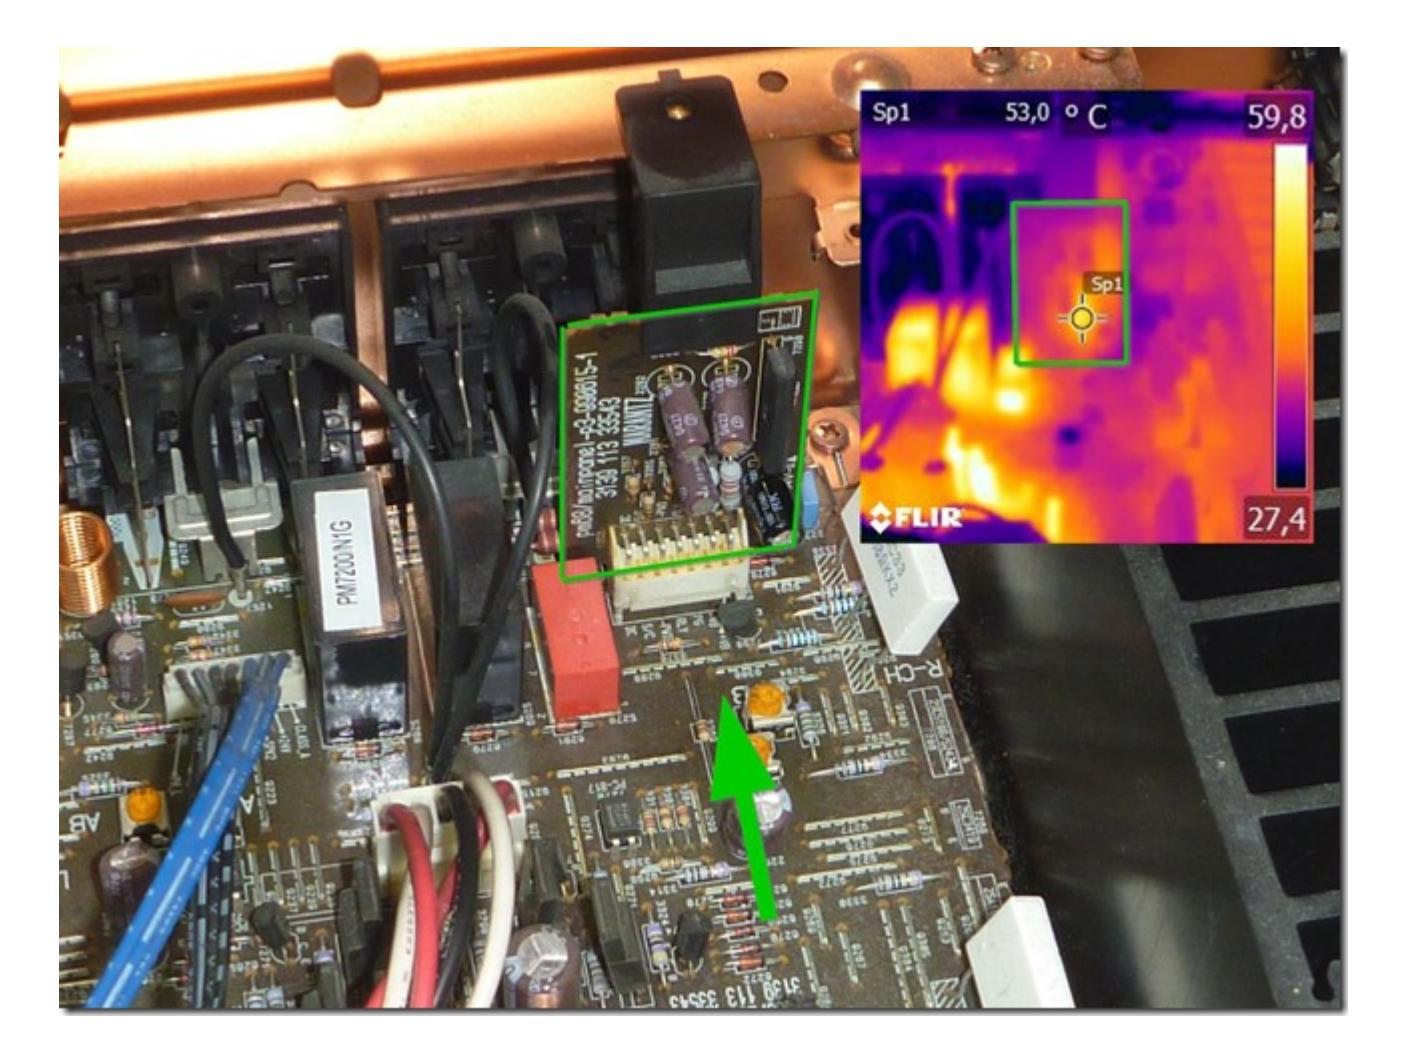
I did some thermal imaging of the protection circuit board. The picture above was taken after 5 minutes idle time of the amplifier (switched on but no signal). The green arrow indicates the approximate direction of the IR Image. The green frame marks the protection circuit board. As you can see there is a hotspot (53 °C) very close to the broken capacitor caused by two 1 W resistors (3364 and 3358). The permanent exposure to heat probably killed the capacitors.

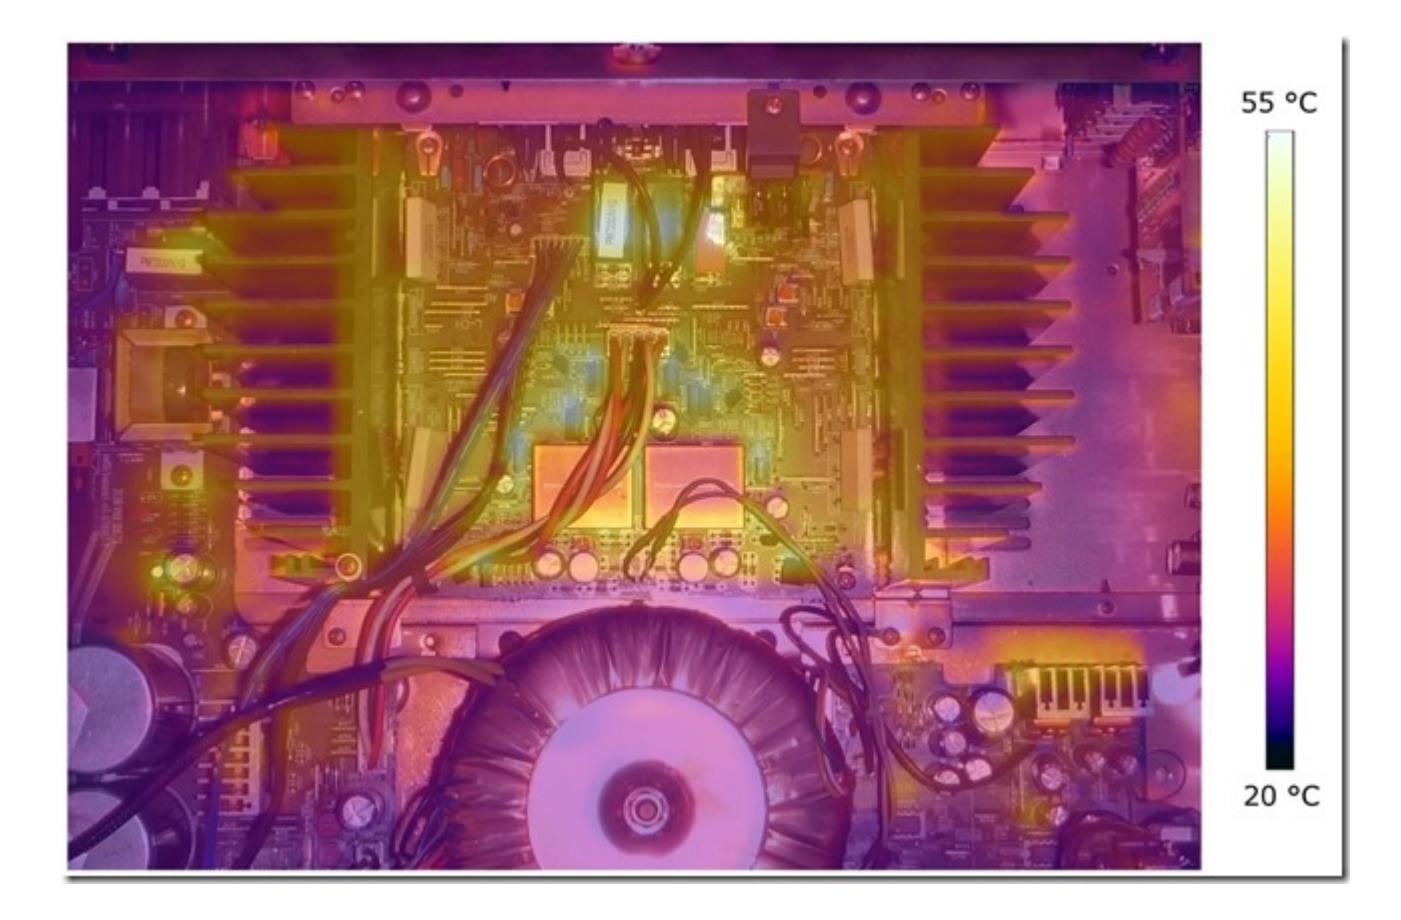
I also did a thermal image of the whole main amplifier board to find other hotspots. To recognize the components better, I made an overlay with a normal picture (I used gimp for that). The overlay is not perfect because of an slightly different angle and focal length of the two cameras. You can see that there are areas that get 55 °C hot if the amplifier is idle (the picture was taken after 10 minutes idle time). In the center area there are some linear regulators that have capacitors close by. I measured some of those capacitors and all seem to have degraded so I went ahead and replaced the ones that where close to heat sources (2264, 2263, 2256, 2255, 2268, 2267).
