Elektra Bregenz GIF 3003 X dishwasher repair

Marantz PM7200 repair

Fluke 233 Display repair

Battery replacement on the Olympus BN-1

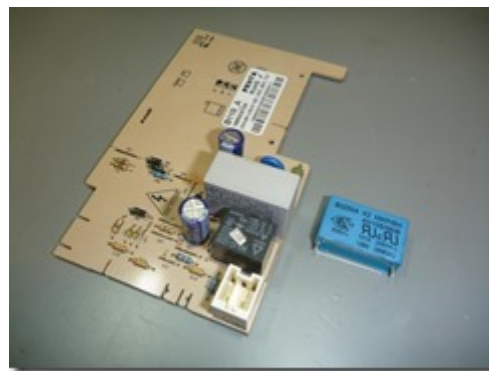
After some further measurements I found that the real cause of the problem was the power supply. This dishwasher uses a capacitive power supply (Wikipedia: https://en.wikipedia.org/wiki/Capacitive_power_supply). With the LCR meter it was quite easy to find that the 1 μ F capacitor had died. I think this is a little design flaw. Because of the placement of the control circuit, the capacitor is exposed to the inside temperature of the dishwasher (~ 65°C when the dishwasher is working). There is hardly any thermal insulation present. Fore sure this has reduced the lifetime of the capacitor significantly.

So the only thing to do was to replace the bad capacitor and everything was working again perfectly.

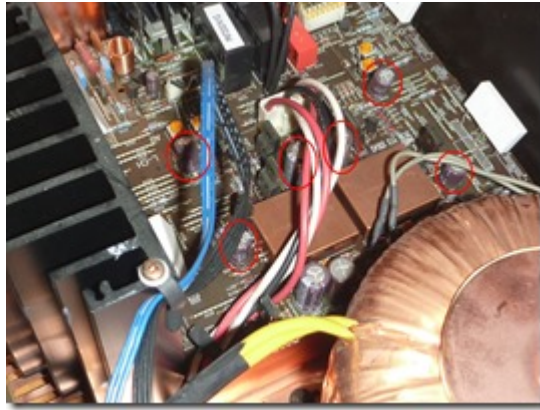
In the schematic above I marked all the components that I replaced. If you replace them, be sure to use 105 °C rated capacitors. The capacitors of the power supply where ok so I didn't replace them. Be sure to do a DC offset voltage alignment and an idling current adjustment after you replace those components. At my unit the values have drifted a bit. You find detailed instructions on how to perform this adjustment in the service manual at page 34.

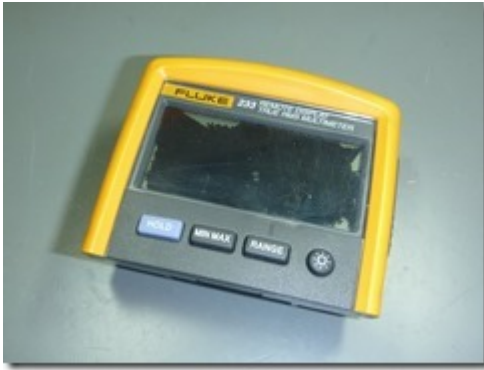
Next I took a closer look at the top unit. As you can see on the pictures the LCD Display was damaged. I ordered the replacement part from the Fluke distributor in Austria (Analog & Digital Messtechnik; <http://www.kalibration.at/>). The part number for the broken display is "LCD RDX (3385697)".

On two of the battery terminals there was a bit of corrosion. Probably someone had left batteries too long in there. With a screwdriver and some alcohol prep pads the dirt came off really easy.

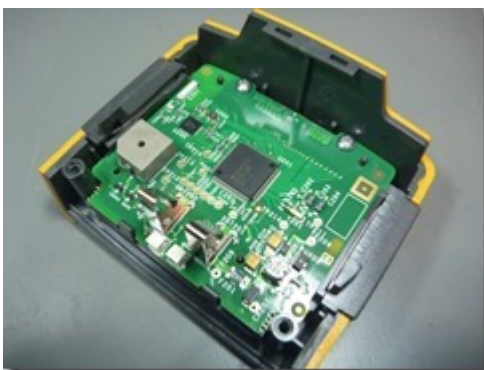
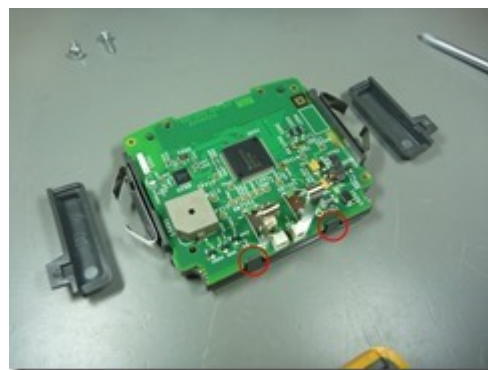
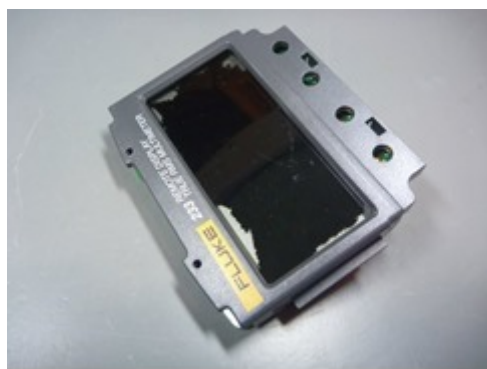
After you removed the PCB from the housing the display is still connected to the PCB. You have to pry open the red

marked plastic clips gently. The LCD assembly will then come off.

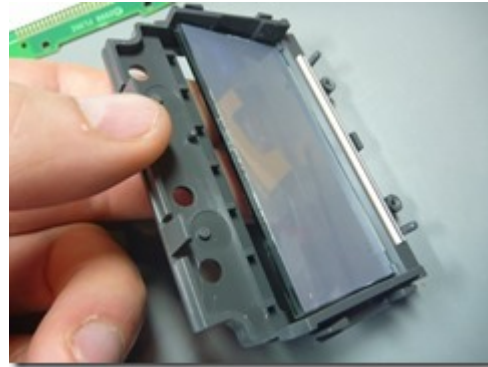
In order to change the LCD you have to lift it slightly up and slide it out in the directions of the buttons. At my unit the conductive rubber zebra stripe was stuck to the PCB. I used a pick to separate it carefully.

I installed the new LCD and reassembled everything again. The yellow rubber was a bit dirty. Alcohol prep pads work good to clean the rubber and let meter look like new. 😊

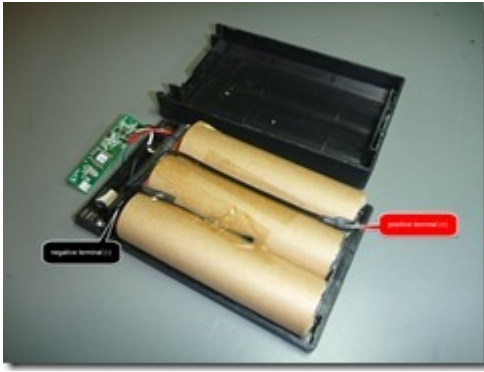
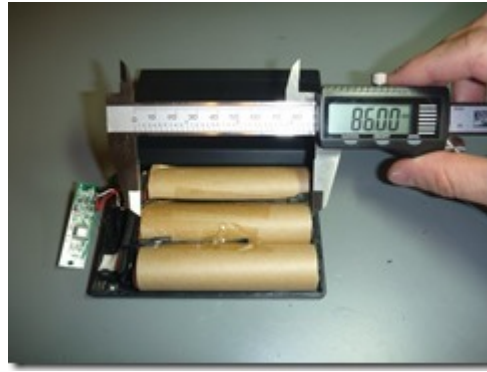
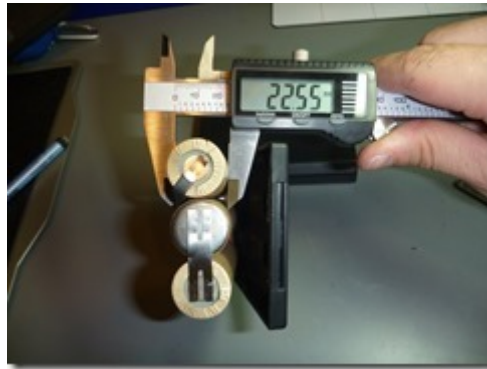
The six batteries are all wired in series ($6 \times 1,2V = 7,2 V$). The two batteries in series are 86mm long and have a diameter of 22,5mm.

So our replacement batteries have to be smaller than 42mm x 22,5mm (length x diameter) .

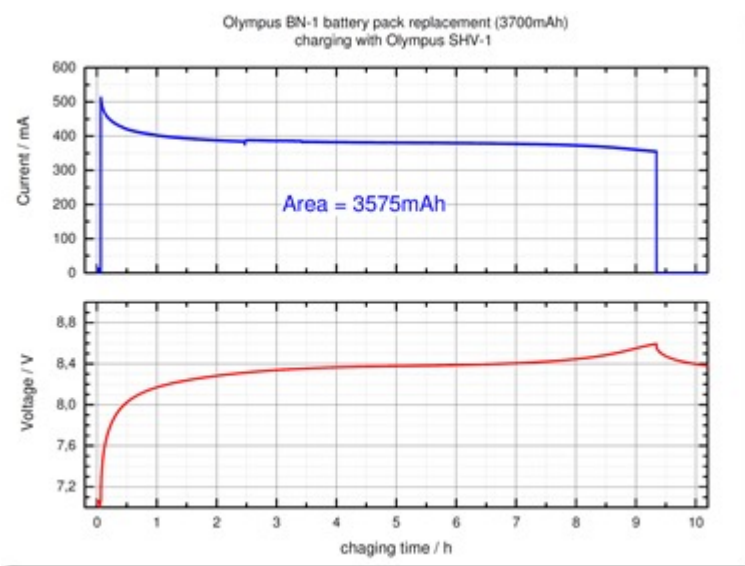
I monitored a full charging cycle with my bench top multimeter. The battery was charged with the Olympus charger (I had small copper strips to tap of the connections). I wanted to ensure that there are no problems (like a timeout) because of the increased capacity.

The charging worked just fine and took approximately 10 hours.

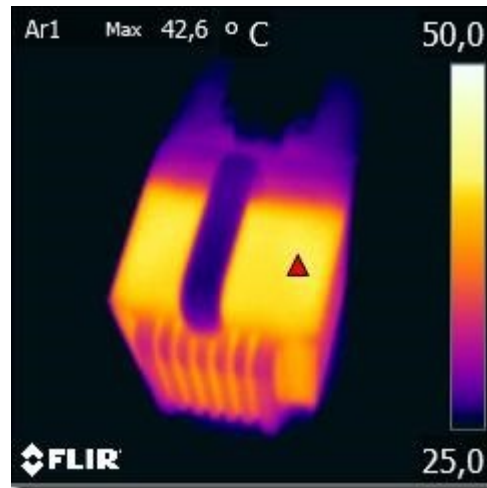
I also took infrared pictures every half hour to see how the temperature rises and what the maximum temperature is.

After three hours the temperature was steady and didn't increase any more. The room temperature was at about 24°C.

The Breve-Tufvassons PFS 250 doesn't come with a power switch so you either have to leave it on all the time or always pull the plug. Because I didn't like neither I just installed a little switch in front of the unit. Now I can turn the transformer on when I have a device plugged in and the other
