# Elektra Bregenz GIF 3003 X dishwasher repair

# Marantz PM7200 repair

## Fluke 233 Display repair

## Battery replacement on the Olympus BN-1

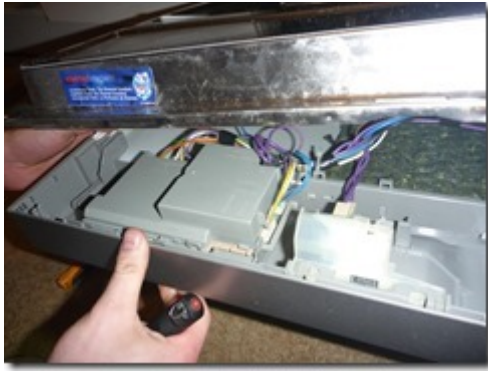
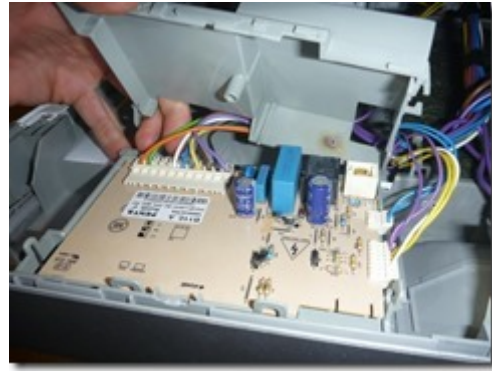
To remove the front, open the dishwasher and undo the screws that are on the inside of the front door. The two screws in the middle hold the wood faceplate. You don't need to take the faceplate off, but It makes the handling a bit easier (however to mount it back on it is good to have someone that helps you).

When you have removed all the screws, the front will split into two parts. The electronic is positioned at the front left corner (where the buttons are). It is enclosed in a separate plastic case that you can flip open after you remove the cables.

When you look on the second picture you may already can spot that there are some burning marks on the backside of the plastic cover right where the relay sits.

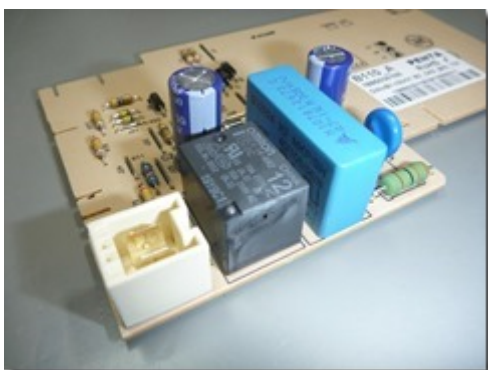
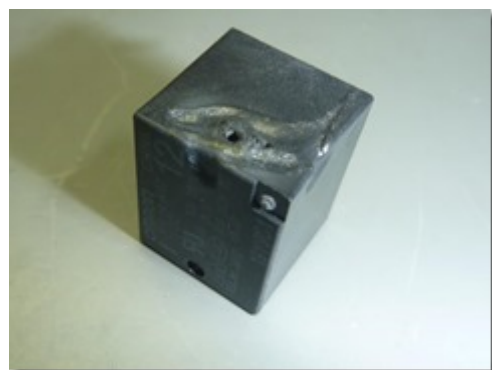
When I inspected the PCB closer, I saw that the relay, that switches the heating element, had a hole in it. Yes, a hole!

I have no idea what can cause a relay to look like this. I measured the heating element and the resistance was fine. So I

went ahead and replaced the relay ... but that didn't solve the initial problem. The dishwasher still switched itself off.

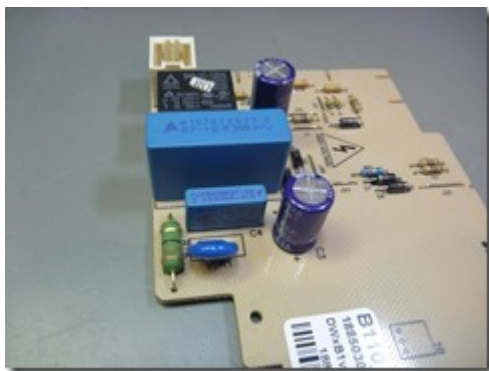
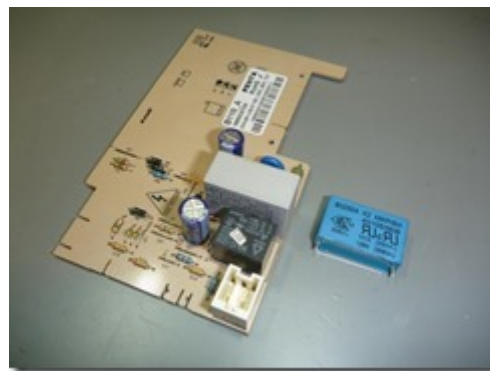
After some further measurements I found that the real cause of the problem was the power supply. This dishwasher uses a capacitive power supply (Wikipedia: [https://en.wikipedia.org/wiki/Capacitive\\_power\\_supply](https://en.wikipedia.org/wiki/Capacitive_power_supply)). With the LCR meter it was quite easy to find that the 1 $\mu$ F capacitor had died. I think this is a little design flaw. Because of the placement of the control circuit, the capacitor is exposed to the inside temperature of the dishwasher (~ 65°C when the dishwasher is working). There is hardly any thermal insulation present. Fore sure this has reduced the lifetime of the capacitor significantly.

So the only thing to do was to replace the bad capacitor and everything was working again perfectly.

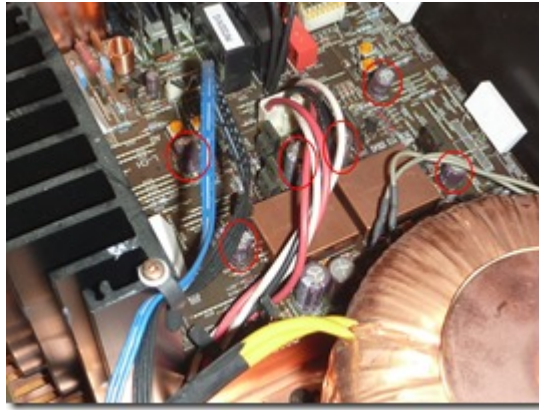
In the schematic above I marked all the components that I replaced. If you replace them, be sure to use 105 °C rated capacitors. The capacitors of the power supply where ok so I didn't replace them. Be sure to do a DC offset voltage alignment and an idling current adjustment after you replace those components. At my unit the values have drifted a bit. You find detailed instructions on how to perform this adjustment in the service manual at page 34.

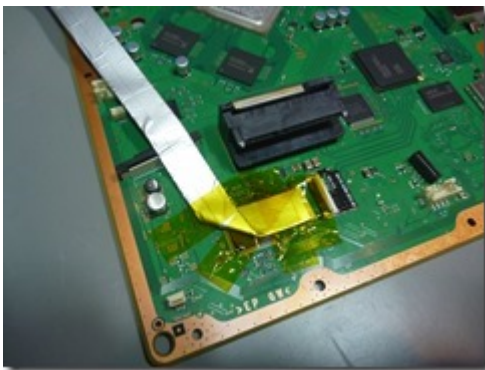
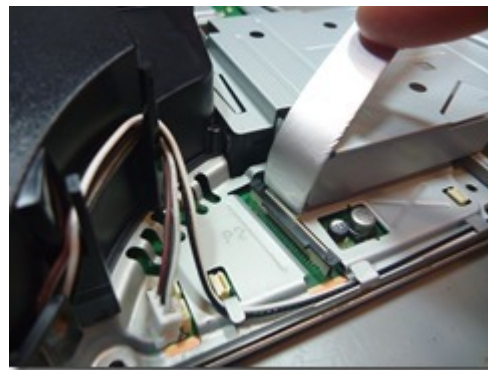
The power cable installation is documented in the manual. Be careful to plug the cable in the right way. The tapping where the small cables are need to be on the power supply side. I did it wrong the first time (the PS will not turn on). In the picture below you can see the position in which I mounted the ODE V5.10b. Additional to the double sided tape I secured the PCB with lots of Kapton tape. The main reason is, that the plastic below the PCB is not completely flat and the double sided tape only touches part of it.

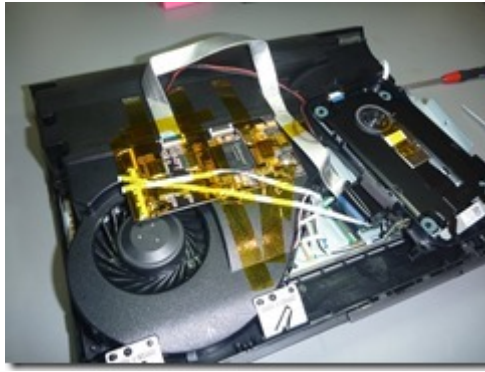
You also have to connect the small cable to the cover switch. Because of the placement of the PCB (I don't think there is a better place) the cable provided are hardly long enough. To install the cover switch cable I lifted the optical drive out of its position a bit closer to the PCB. After connecting the cable you can put the drive carefully back. You will see that the cable is under a bit of tension, but I think it will do. The position of the larger cable is not fixed yet.

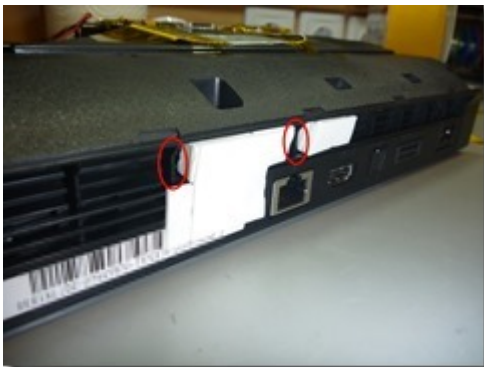
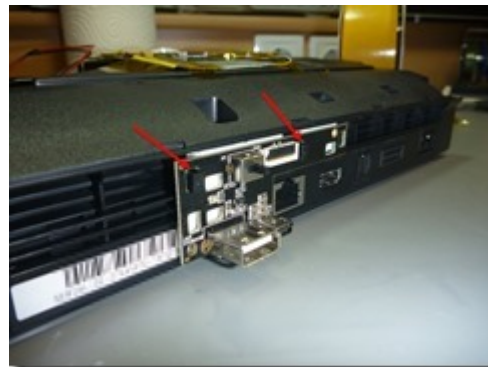
The next step is to install the clip on PCB. I used the provided plastic clips. I only used clips on the position 4 and 6 as shown in the manual at figure 2.35. To give the PCB more stability I additionally used double sided tape. This is also done in the YouTube video mentioned at the beginning from 19m12s onwards. In contrast to the YouTube how-to keep the areas clear where the clips will clip on the fan inlets.

After that you can install the two cables. I secured them firmly with Kapton. The last thing to do is to attach the power cable and fixate it.

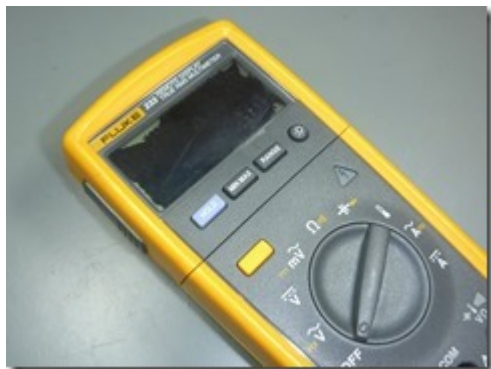
When the unit arrived I was able to turn it on and the continuity buzzer worked just fine 😊

The special thing about this meter is, that you can separate it into the base unit and the display unit. They communicate by wireless transmission up to 10m.

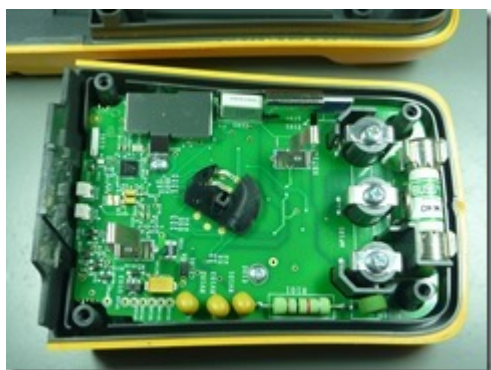
At first let's have a look at the base unit. I took it apart in order to check if the right fuse is in the meter (you never know on used equipment).

The build quality is (as to be expected from fluke) superb. This unit seems to be in good condition. No parts were damaged or dirty.

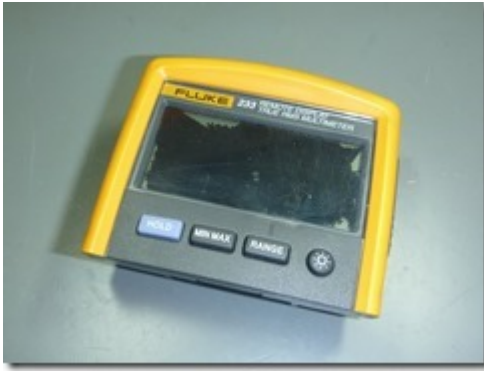
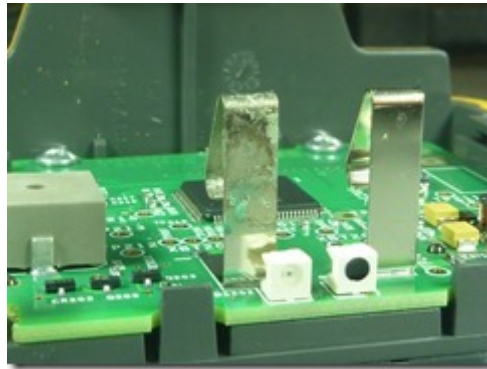
On two of the battery terminals there was a bit of corrosion. Probably someone had left batteries too long in there. With a screwdriver and some alcohol prep pads the dirt came off really easy.

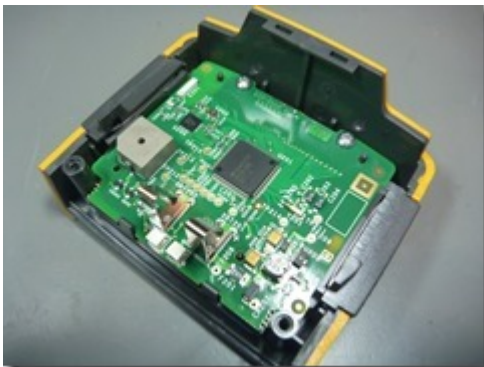
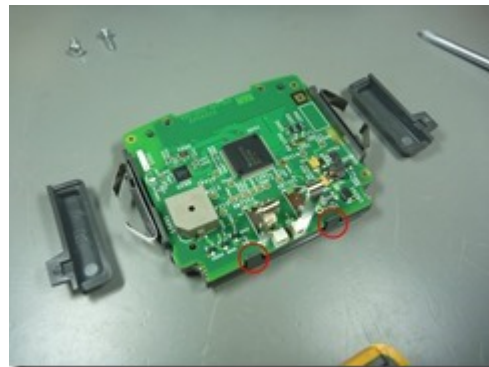
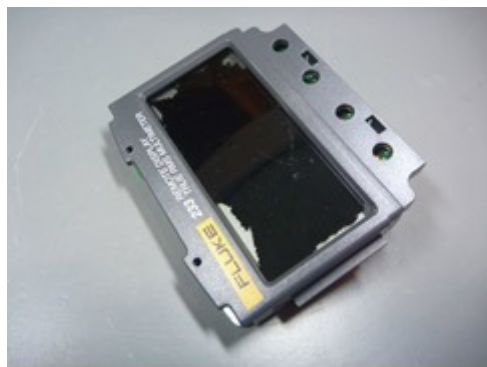
After you removed the PCB from the housing the display is still connected to the PCB. You have to pry open the red

marked plastic clips gently. The LCD assembly will then come off.

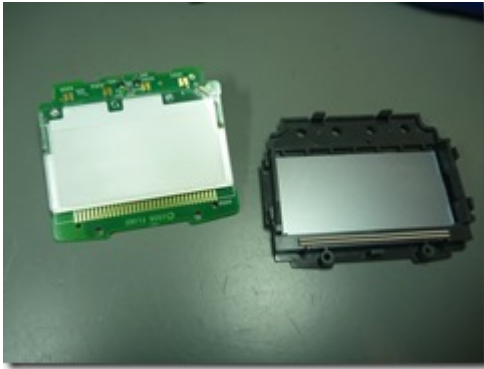
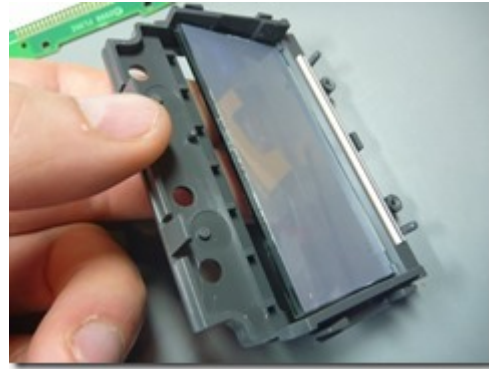
In order to change the LCD you have to lift it slightly up and slide it out in the directions of the buttons. At my unit the conductive rubber zebra stripe was stuck to the PCB. I used a pick to separate it carefully.

I installed the new LCD and reassembled everything again. The yellow rubber was a bit dirty. Alcohol prep pads work good to clean the rubber and let meter look like new. 😊

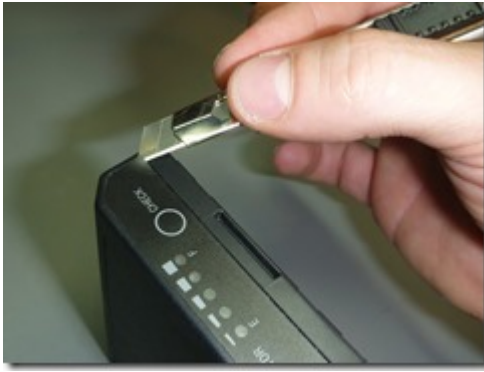
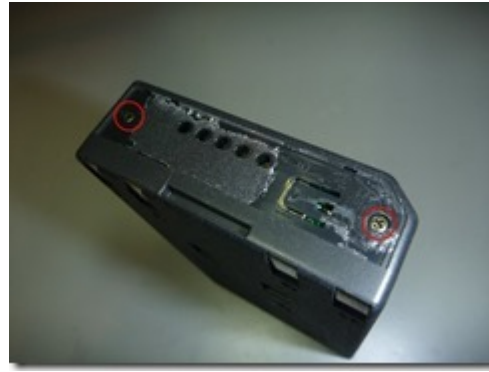
Under the plastic you will find two PH0 screws. After you remove them you can lift out the plastic cover of the small PCB.

You will see the PCB that is again secured with 2 PH0 screws. After those screws are removed you can lift out the PCB a bit. On the rear side of the PCB there are 5 cables. 3 thicker ones (red, white, black) and two smaller black cables. The two smaller black cables go to a temperature sensor. Be careful not to cut or damage them.

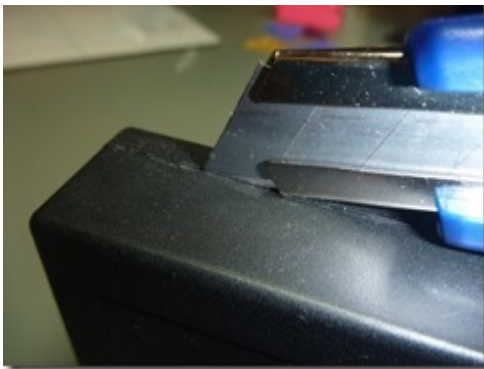
around the case where the upper and the lower part have been welded together. I used a cutting blade and repeatedly cut along the edge.

BE PATIENT! ... it took me nearly half an hour to get the case open. Be careful not to cut too deep (the batteries are close behind the wall). You can feel it when you penetrated the case. Just take your time and work slowly and carefully. I used a prying tool to separate the upper and lower part just a bit so that the cutting knife gets a bit more room.

The sides went apart easy ... but at the bottom the case had a better connection. I used two prying tools and pushed them right till the bottom. With patience and a little force (tilt the upper part towards the bottom) the case snapped apart.

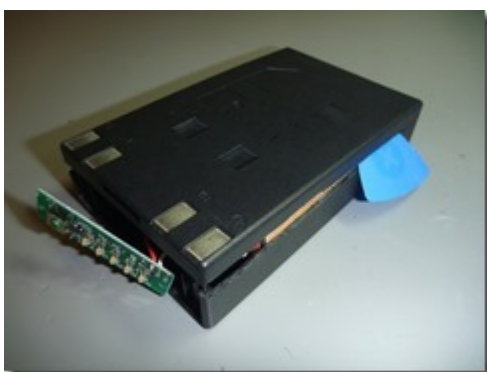
There are 6 single sub C cells that are joined in serial.

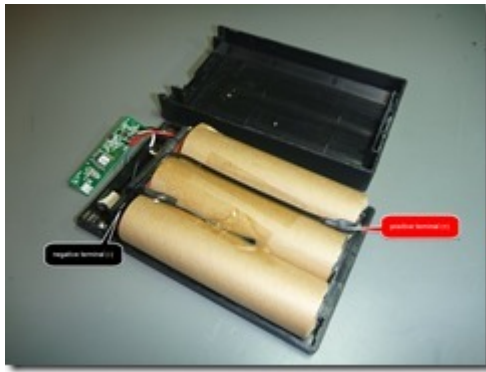
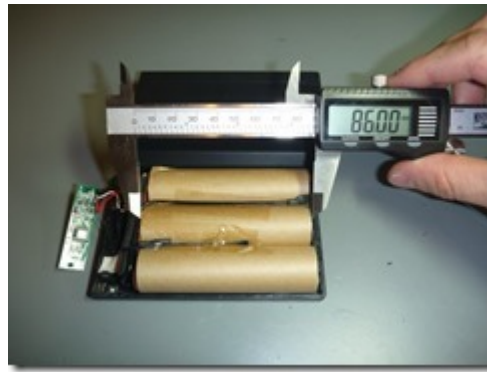
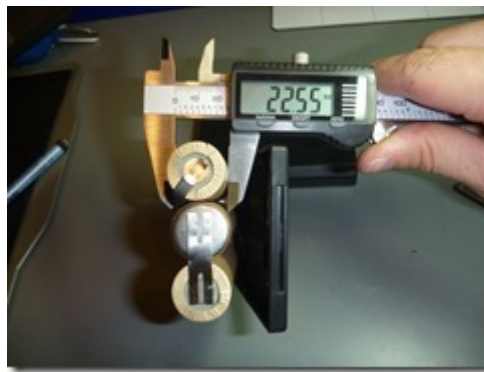
The six batteries are all wired in series ( $6 \times 1,2V = 7,2 V$ ). The two batteries in series are 86mm long and have a diameter of 22,5mm.

So our replacement batteries have to be smaller than 42mm x 22,5mm (length x diameter) .

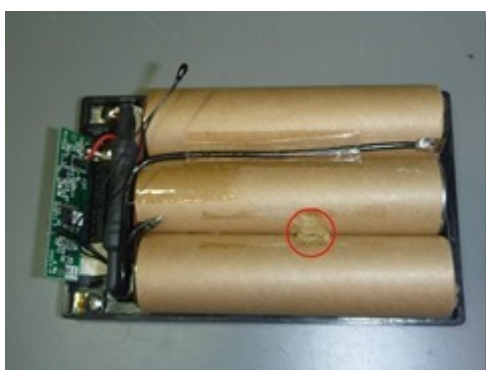
In order to remove the battery pack from the case you have to carefully loosen the temperature sensor from the battery. The sensor is podded in some kind of elastic glue. Just use a screwdriver and carefully peel it out.

After that you can unsolder the wires that connect to to the battery pack.

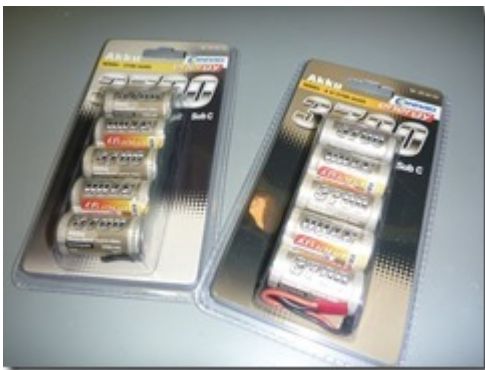
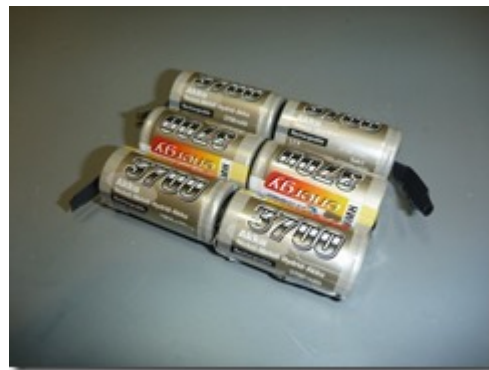
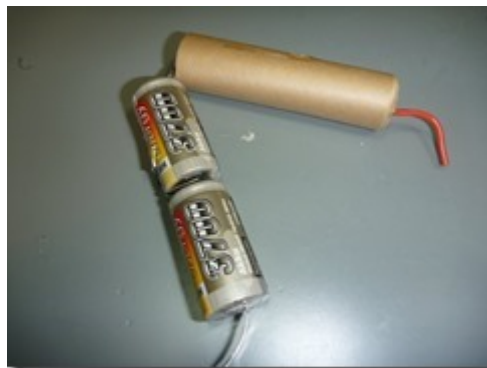
In the electronic shop nearby they had battery packs where the single cell size matched. These packs are designed for RC usage. This means that they can provide a high peak current (perfect for our application). I took cells that had a higher capacity (3700mAh instead of 2600mAh);. Sadly there was no pack with the right alignment of the single cells so I had to align them. I reused the paper cover to isolate the new battery pack.

To fixate the new battery pack in the cover I used very thin double side adhesive tape (some Tesa that is usually used for sticking photos to an album).

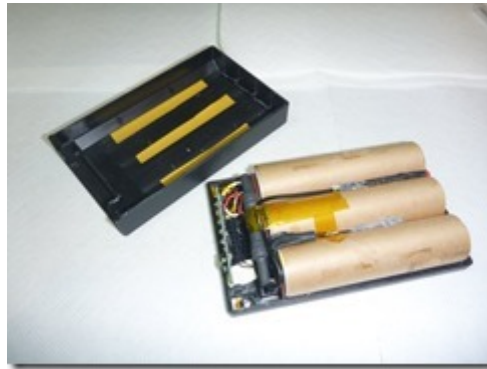
I resoldered the connection wires and glued the temperature sensor in place. Before gluing the temperature sensor I put some thermal compound between the battery pack and the temperature sensor.

Don't stick on the top cover of the battery pack right now. There would be a small gap where we cut the case apart.

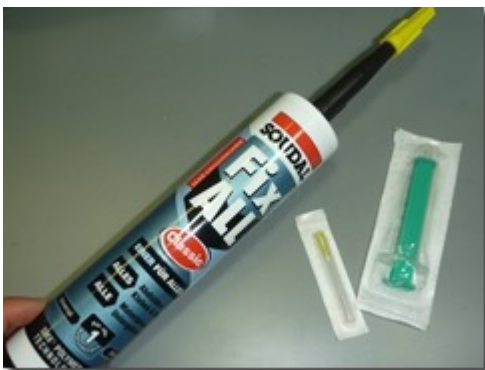
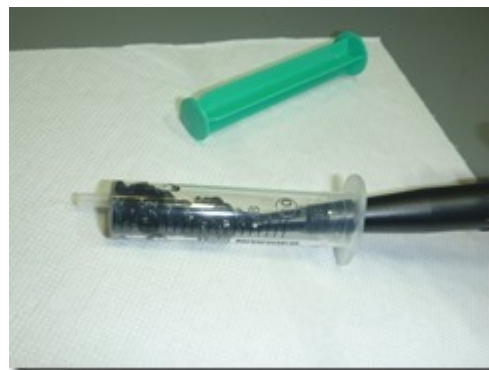
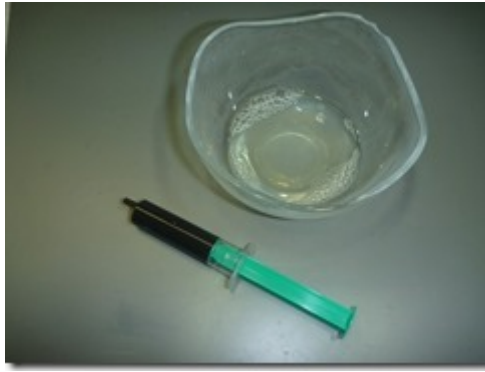
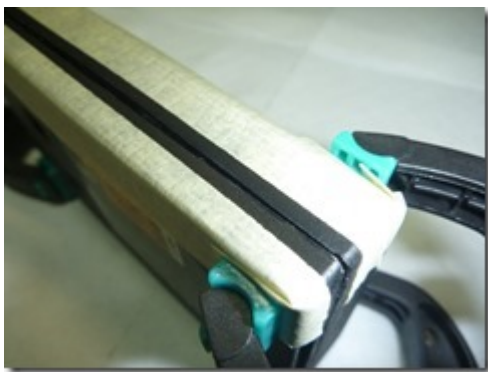
I used construction silicone glue to rejoin the case. In order to be able to allot the silicone more accurate I decanted it from the big cartridge to a smaller syringe. You also should prepare a small bowl with water and add a drop of dishwashing liquid to it. You can then dip your finger in this fluid and the silicone will not stick. This way you can smoothen it later on.

Before applying the silicone you should put tape around the outside of both of the case halves. I positioned the tape approximately 1mm away from the edge.

Apply a small amount of the construction silicone around the edge of the lower case. Don't use too much or it will get messy once you put the case together. If it really is too little (trust me there won't) you can apply more when the case is put together.

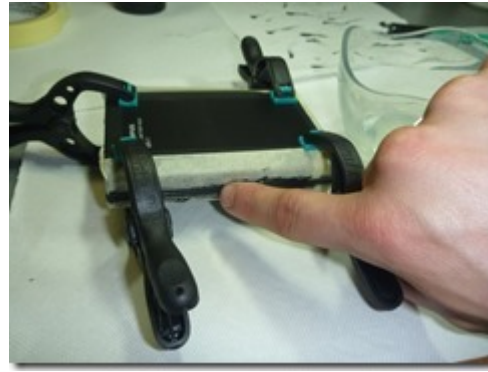
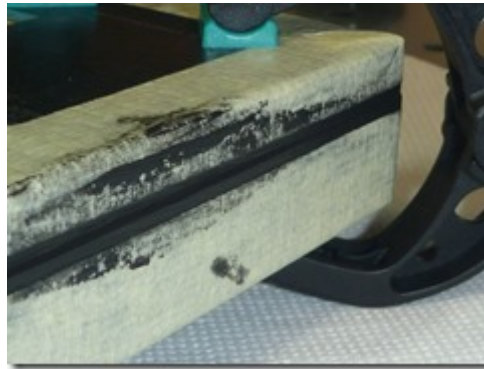
After you applied the silicone you can put the case together. I used four clamps to press it so that there is hardly any gap. Now you can use your finger (dip it in the dishwasher liquid first) to smoothen / remove the silicone that got squeezed out of the case.

Let it dry for at least 24 hours (depending on the type of silicone you used). After drying you can remove the tape.

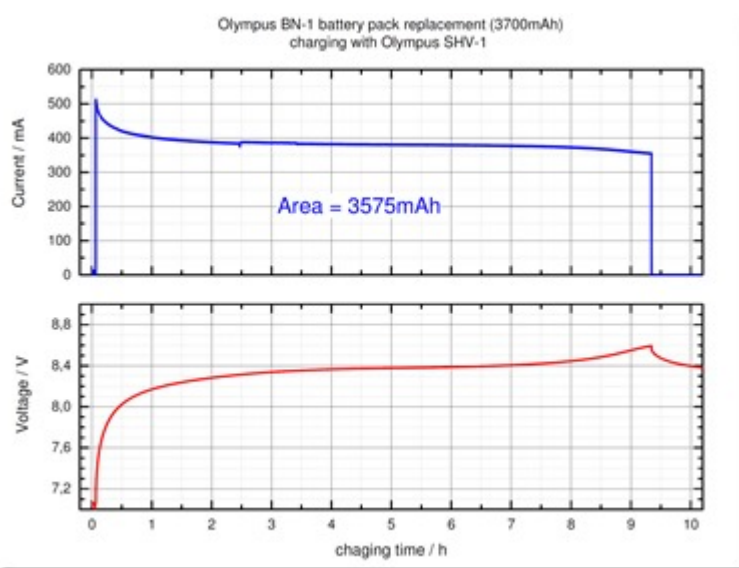
I monitored a full charging cycle with my bench top multimeter. The battery was charged with the Olympus charger (I had small copper strips to tap of the connections). I wanted to ensure that there are no problems (like a timeout) because of the increased capacity.

The charging worked just fine and took approximately 10 hours.

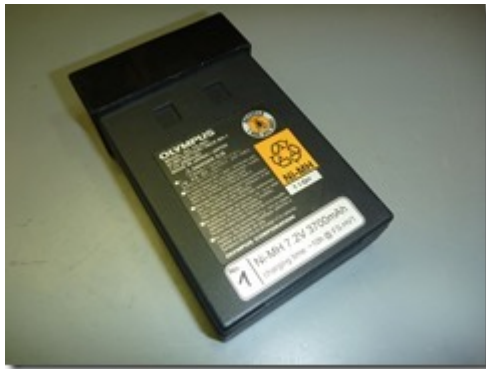
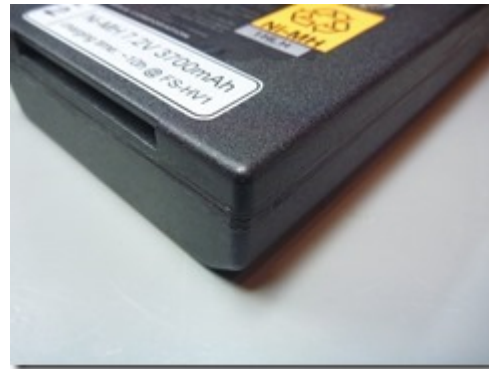
The last thing I did was to put an additional marking on the battery pack so that it can be identified easily.

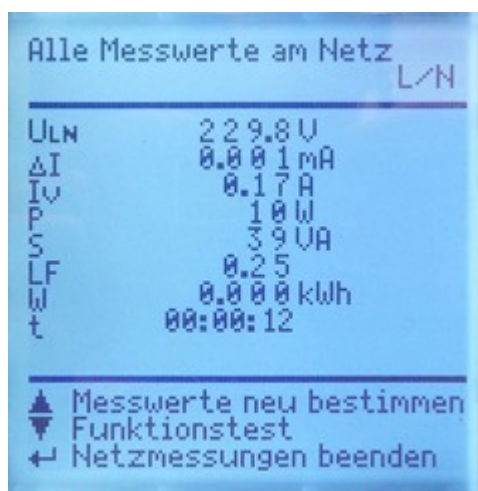
At home I plugged the unit into my Gossen Metrawatt Secutest SII+ and left it on for three hours. In the picture below you can see a measurement of the power consumption. The power consumption was constant at 10W.
