Elektra Bregenz GIF 3003 X dishwasher repair

Marantz PM7200 repair

Fluke 233 Display repair

Battery replacement on the Olympus BN-1

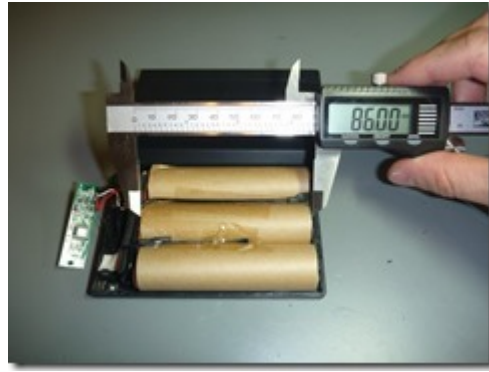
The six batteries are all wired in series ($6 \times 1,2V = 7,2 V$). The two batteries in series are 86mm long and have a diameter of 22,5mm.

So our replacement batteries have to be smaller than 42mm x 22,5mm (length x diameter) .
