Elektra Bregenz GIF 3003 X dishwasher repair

Marantz PM7200 repair

Fluke 233 Display repair

Battery replacement on the Olympus BN-1

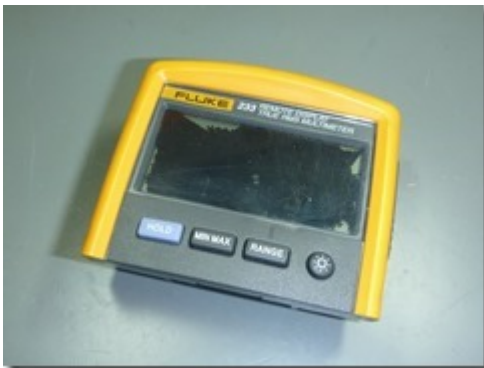
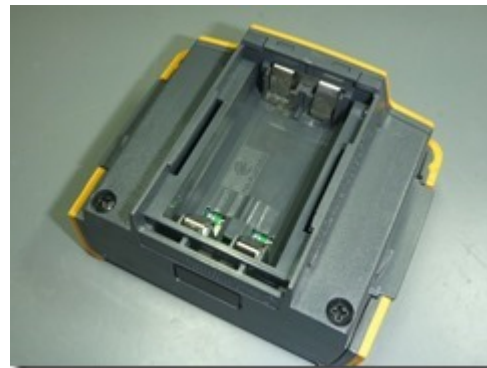
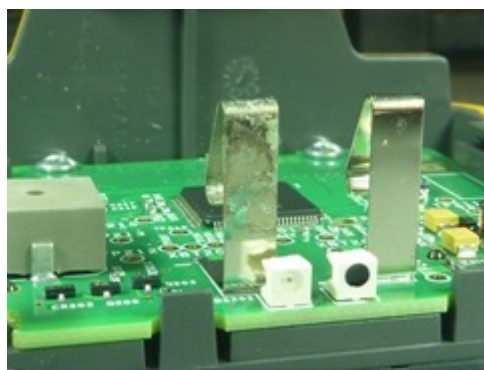
Next I took a closer look at the top unit. As you can see on the pictures the LCD Display was damaged. I ordered the replacement part from the Fluke distributor in Austria (Analog & Digital Messtechnik; <http://www.kalibration.at/>). The part number for the broken display is "LCD RDX (3385697)".

On two of the battery terminals there was a bit of corrosion.

Probably someone had left batteries to long in there. With a screwdriver and some alcohol prep pads the dirt came off really easy.

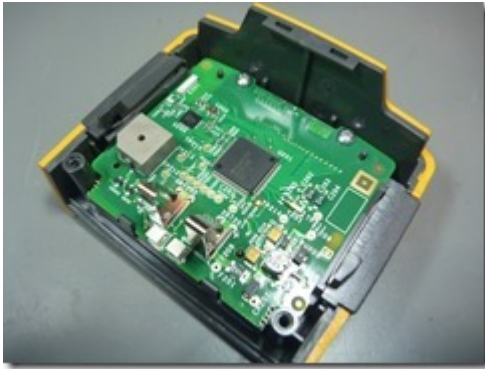
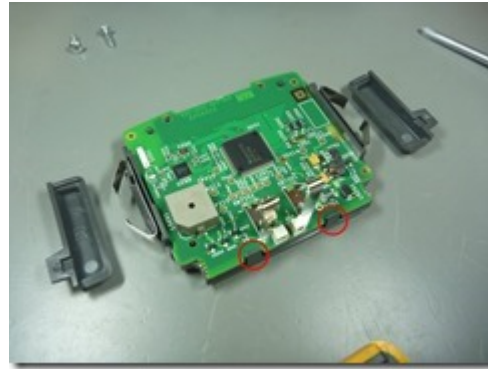
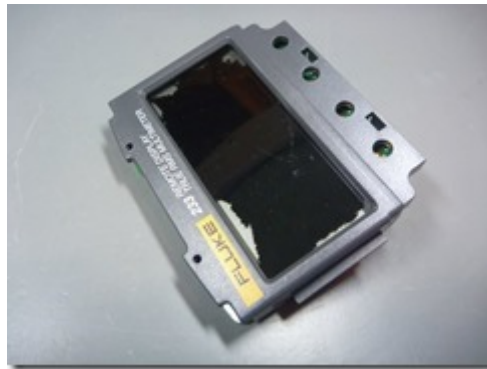
After you removed the PCB from the housing the display is still connected to the PCB. You have to pry open the red marked plastic clips gently. The LCD assembly will then come off.

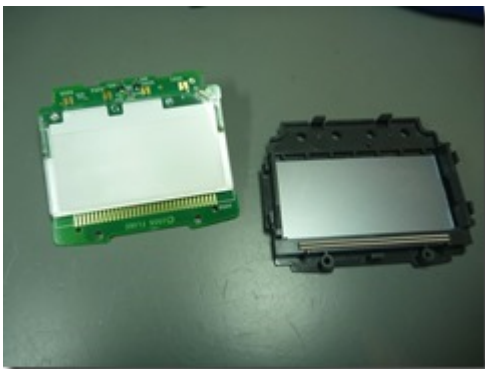
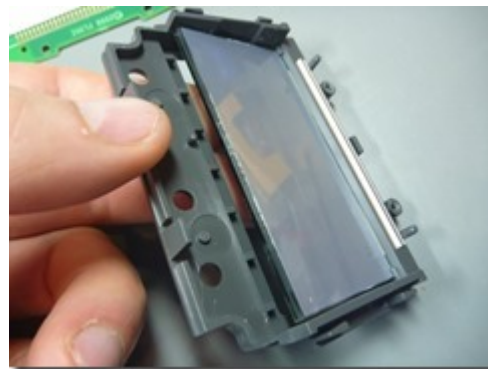
In order to change the LCD you have to lift it slightly up and slide it out in the directions of the buttons. At my unit the conductive rubber zebra stripe was stuck to the PCB. I used a pick to separate it carefully.

I installed the new LCD and reassembled everything again. The yellow rubber was a bit dirty. Alcohol prep pads work good to clean the rubber and let meter look like new. 🤪

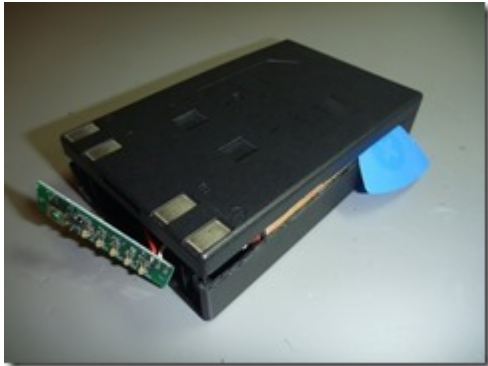
There are 6 single sub C cells that are joined in serial.

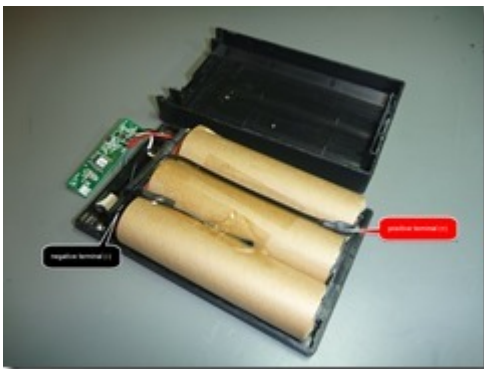
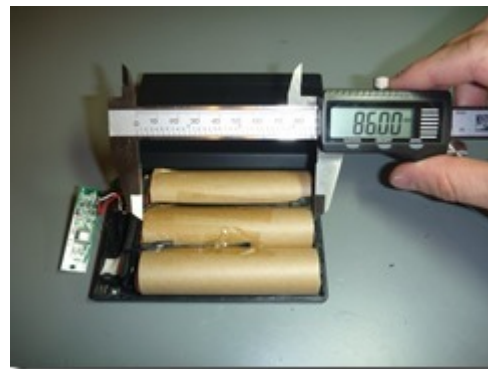
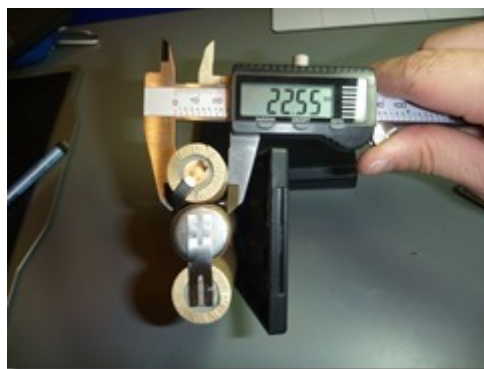
The six batteries are all wired in series ($6 \times 1,2V = 7,2 V$). The two batteries in series are 86mm long and have a diameter of 22,5mm.

So our replacement batteries have to be smaller than 42mm x 22,5mm (length x diameter) .

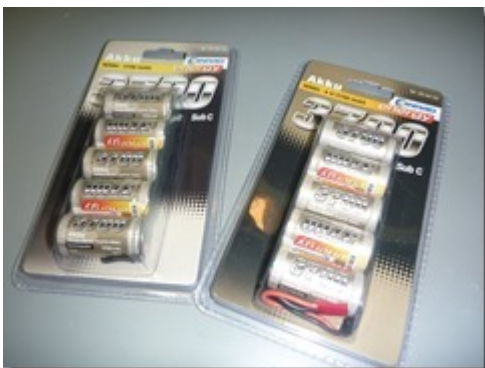
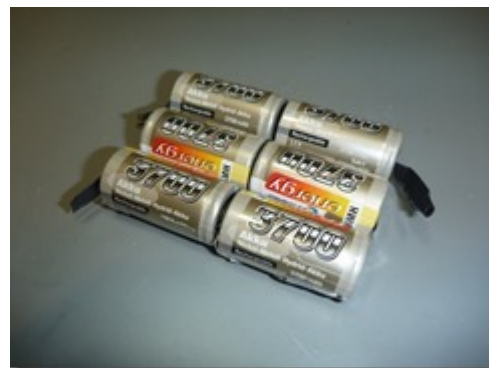
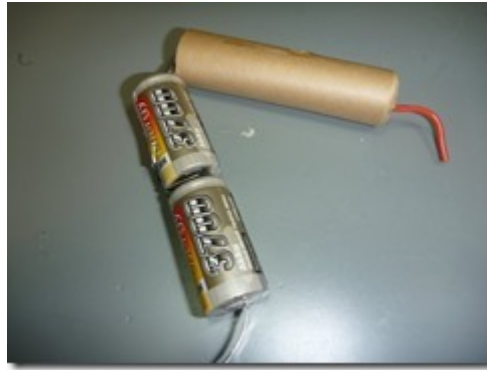
In the electronic shop nearby they had battery packs where the single cell size matched. These packs are designed for RC usage. This means that they can provide a high peak current (perfect for our application). I took cells that had a higher capacity (3700mAh instead of 2600mAh);. Sadly there was no pack with the right alignment of the single cells so I had to align them. I reused the paper cover to isolate the new battery pack.

To fixate the new battery pack in the cover I used very thin double side adhesive tape (some Tesa that is usually used for sticking photos to an album).
