Elektra Bregenz GIF 3003 X dishwasher repair

Marantz PM7200 repair

Fluke 233 Display repair

Battery replacement on the Olympus BN-1

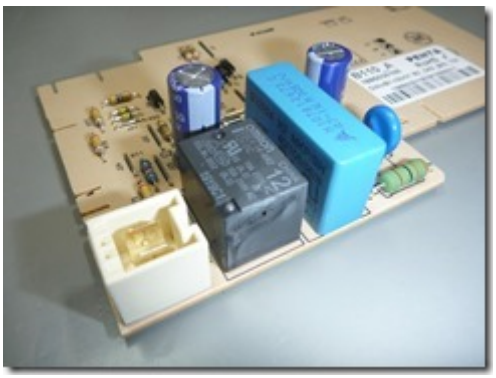
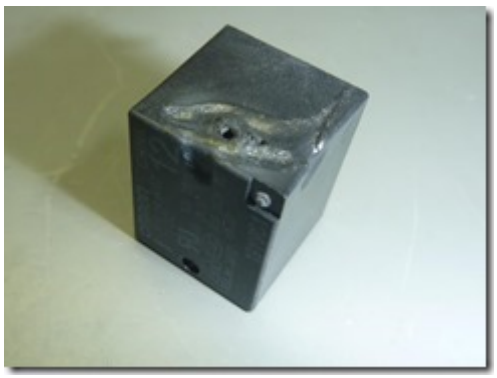
When you have removed all the screws, the front will split into two parts. The electronic is positioned at the front left corner (where the buttons are). It is enclosed in a separate plastic case that you can flip open after you remove the cables.

When you look on the second picture you may already can spot that there are some burning marks on the backside of the plastic cover right where the relay sits.

When I inspected the PCB closer, I saw that the relay, that switches the heating element, had a hole in it. Yes, a hole!

went ahead and replaced the relay … but that didn’t solve the initial problem. The dishwasher still switched itself off.

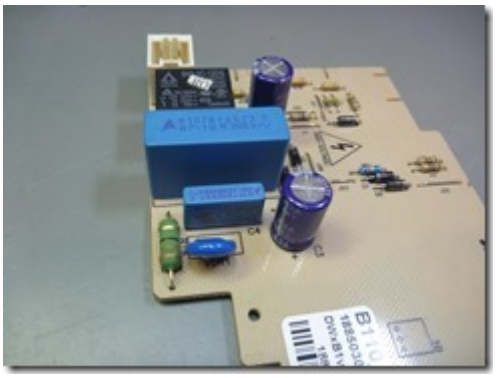
After some further measurements I found that the real cause of the problem was the power supply. This dishwasher uses a capacitive power supply (Wikipedia: https://en.wikipedia.org/wiki/Capacitive_power_supply). With the LCR meter it was quite easy to find that the 1µF capacitor had died. I think this is a little design flaw. Because of the placement of the control circuit, the capacitor is exposed to the inside temperature of the dishwasher (~ 65°C when the dishwasher is working). There is hardly any thermal insulation present. Fore sure this has reduced the lifetime of the capacitor significantly.

So the only thing to do was to replace the bad capacitor and everything was working again perfectly.

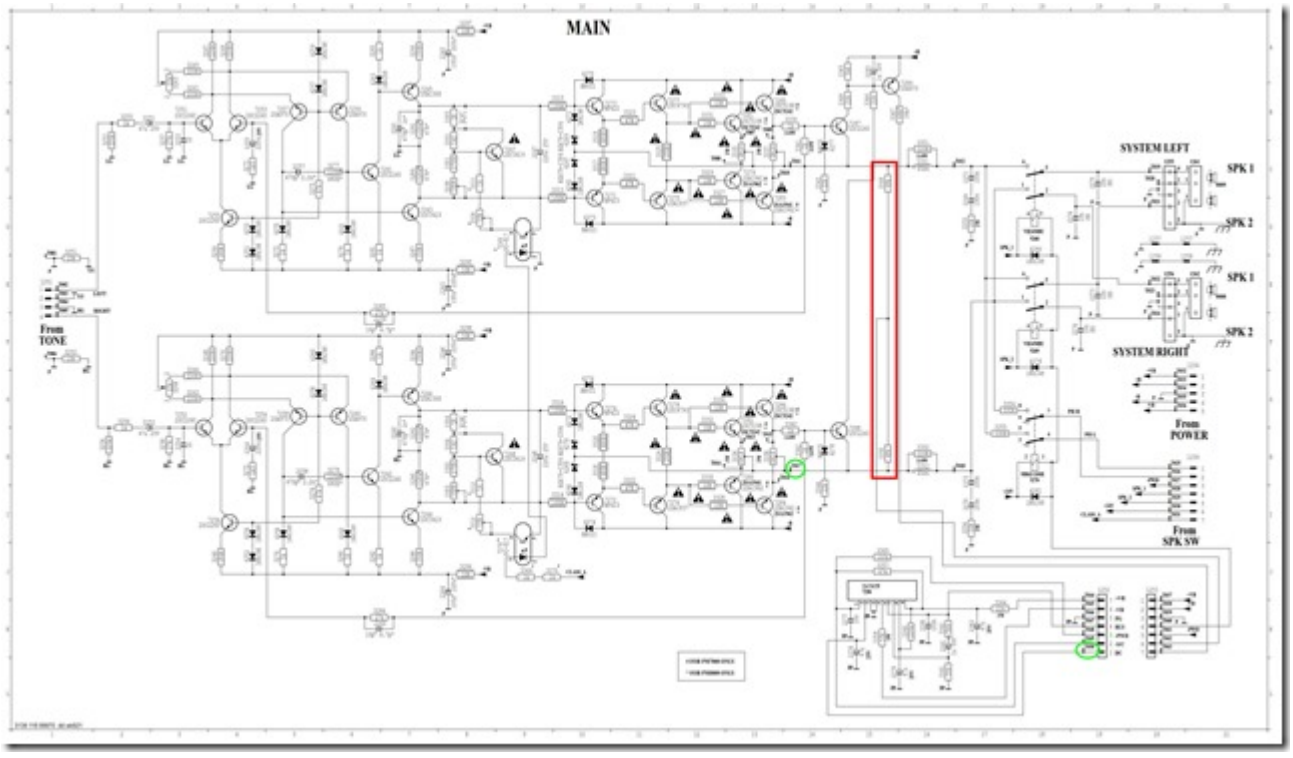
Whenever the output signal reached a certain level, the amplifier switched the outputs off (as I learned later on, that is called the protection mode). This symptom could be provoked by either increasing the input level or increasing the amplification by turning the volume control. The effect occurred on the left and right channel. It didn't matter if I put a signal at both or only at one channel. Also the source of the signal didn't matter.

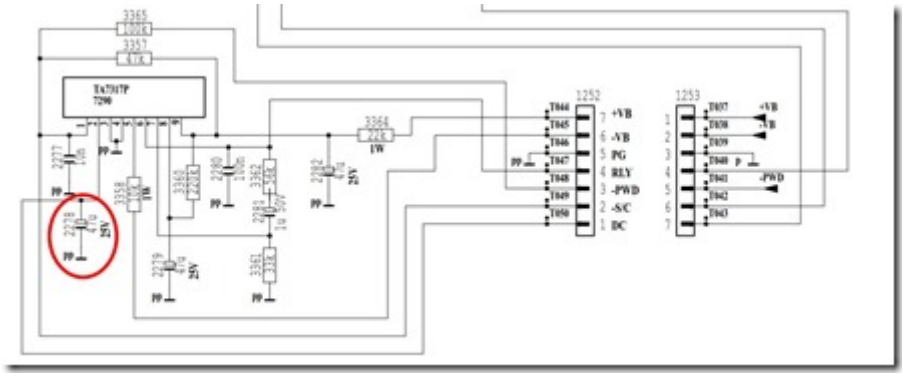
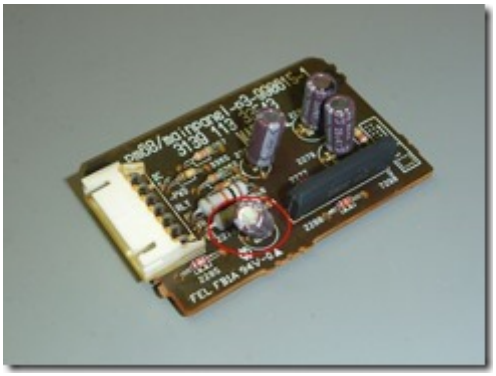
I fed a sine wave (440 Hz, 500 mVpp) to the right and left channel (0° phase shift). I increased the volume so that the error just show up. When I measured the signal (T050 to GND) I saw the same signal shape as at the output stage (T017 to GND). The measurement is shown at the screenshot below. The test points are marked green in the schematic above.

The protection circuit has a TA7317P IC in it. If you look at the datasheet you see that the IC will send the amplifier to protection mode when a voltage level of approximately 1 V is exceeded. With this information it seems plausible that (given the signal at T050 as shown above) the amplifier switches to protection mode.

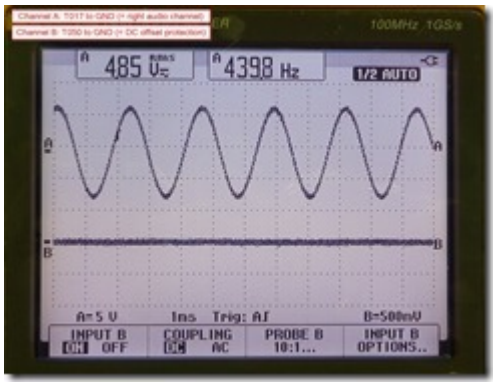
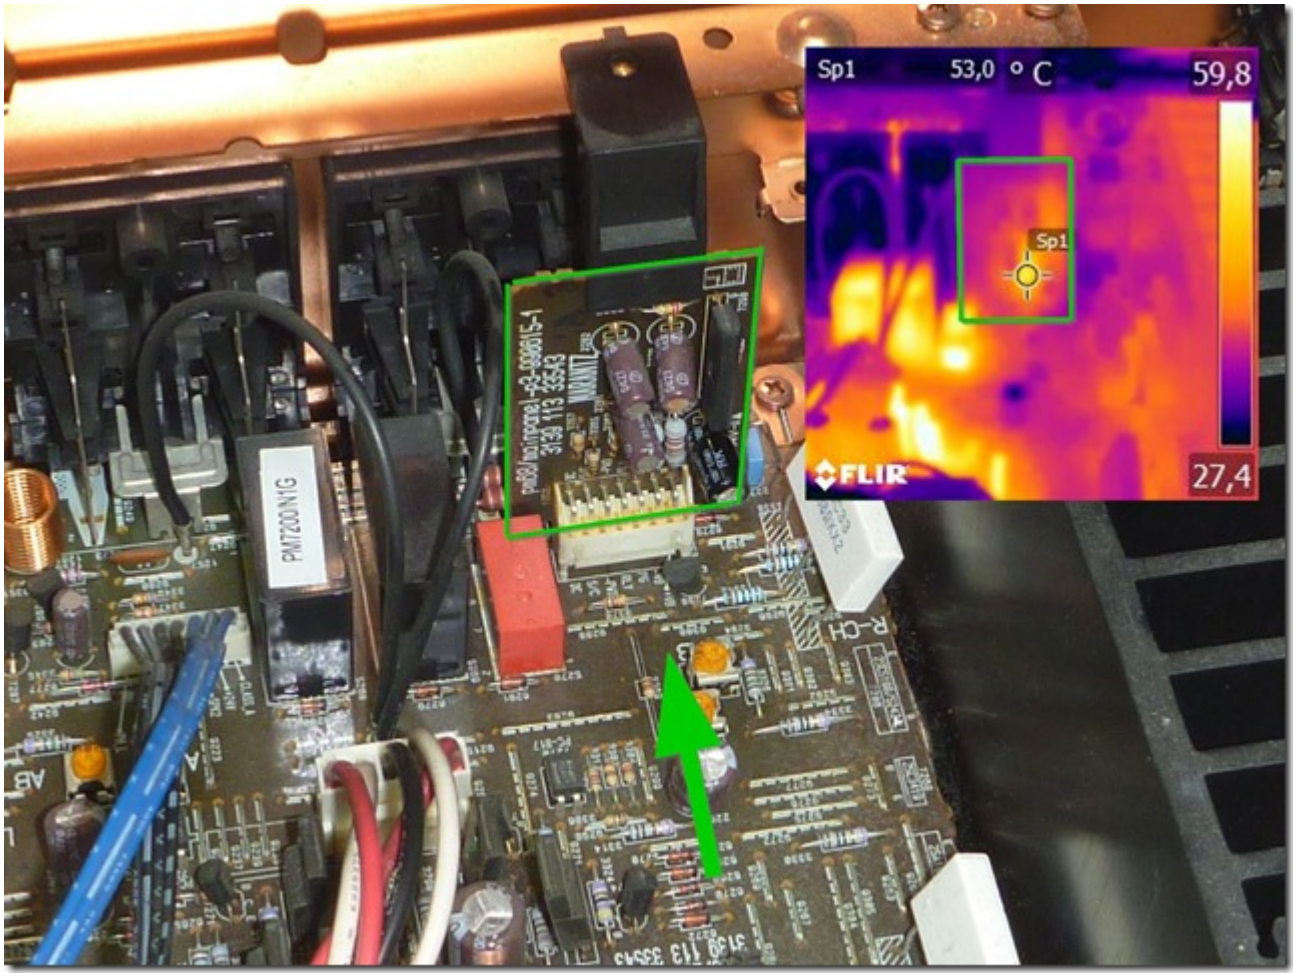
As to be expected the signal at T050 changed drastically. All the AC part was gone and the amplifier didn’t turn off anymore! Yeah … problem found and fixed!
To be safe I replaced all four electrolytic capacitors (2278, 2281, 2282, 2279) on the protection board. I measured them later on and they all where in pretty bad condition.

I did some thermal imaging of the protection circuit board. The picture above was taken after 5 minutes idle time of the amplifier (switched on but no signal). The green arrow indicates the approximate direction of the IR Image. The green frame marks the protection circuit board. As you can see there is a hotspot (53 °C) very close to the broken capacitor caused by two 1 W resistors (3364 and 3358). The permanent exposure to heat probably killed the capacitors.

Some further investigation showed, that there is a capacitor (2278) attached to the DC offset line that should flatten all the AC signals. When I measured the capacitor with the LCR-Meter there was no reading of the capacitance possible (the capacitor was dead). I replaced the capacitor with a new one with the same values (I used a 105 °C rated) and did the first measurement (with 0° phase shift) once more.

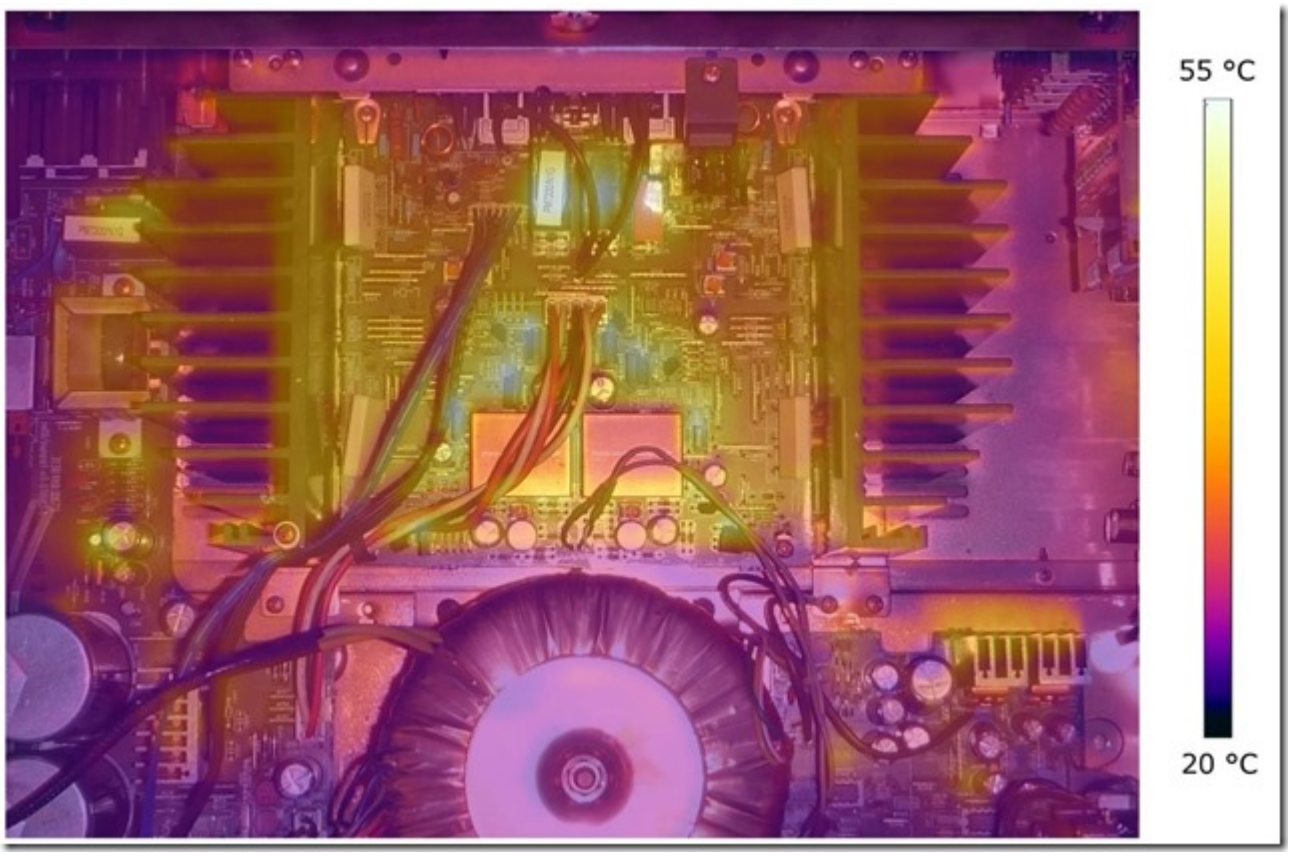
I also did a thermal image of the whole main amplifier board to find other hotspots. To recognize the components better, I made an overlay with a normal picture (I used gimp for that). The overlay is not perfect because of an slightly different angle and focal length of the two cameras. You can see that there are areas that get 55 °C hot if the amplifier is idle (the picture was taken after 10 minutes idle time). In the center area there are some linear regulators that have capacitors close by. I measured some of those capacitors and all seem to have degraded so I went ahead and replaced the ones that where close to heat sources (2264, 2263, 2256, 2255, 2268, 2267).

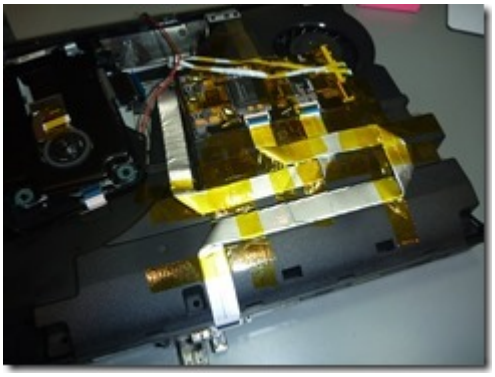
The power cable installation is documented in the manual. Be careful to plug the cable in the right way. The tapping where the small cables are need to be on the power supply side. I did it wrong the first time (the PS will not turn on). The In the picture below you can see the position in which I mounted the ODE V5.10b. Additional to the double sided tape I secured the PCB with lots of Kapton tape. The main reason is, that the plastic below the PCB is not completely flat and the double sided tape only touches part of it.

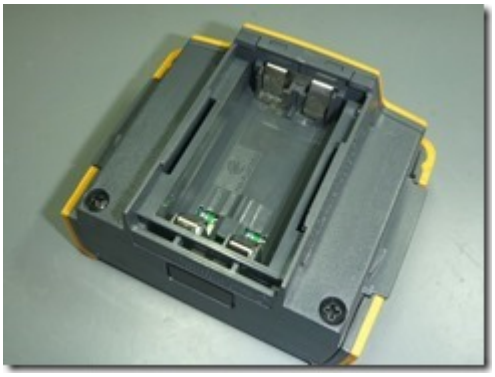
The build quality is (as to be expected from fluke) superb. This unit seems to be in good condition. No parts were damaged or dirty.

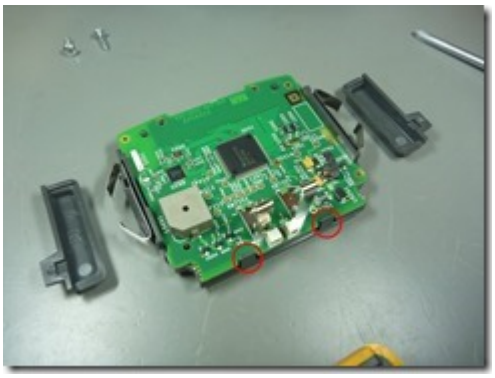
Next I took a closer look at the top unit. As you can see on the pictures the LCD Display was damaged. I ordered the replacement part from the Fluke distributor in Austria (Analog & Digital Messtechnik; http://www.kalibration.at/). The part number for the broken display is “LCD RDX (3385697)”.

On two of the battery terminals there was a bit of corrosion. Probably someone had left batteries to long in there. With a screwdriver and some alcohol prep pads the dirt came off really easy.

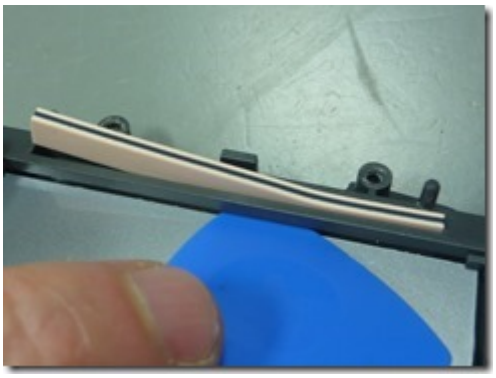
After you removed the PCB from the housing the display is still connected to the PCB. You have to pry open the red

marked plastic clips gently. The LCD assembly will then come off.

In order to change the LCD you have to lift it slightly up and slide it out in the directions of the buttons. At my unit the conductive rubber zebra stripe was stuck to the PCB. I used a pick to separate it carefully.

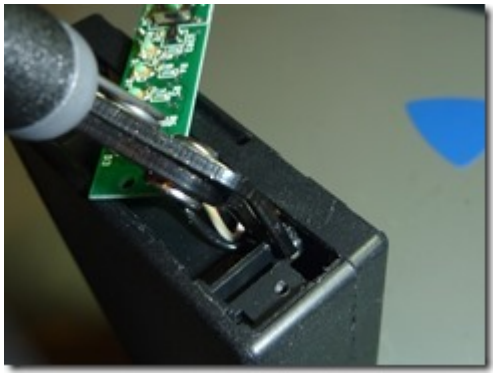
Olympus has molded the plastic case together. There is no easy way to get this apart.

The first step is to cut two small connections that are under the PCB. I used a side cutter to split them. Be careful not to cut the cables.

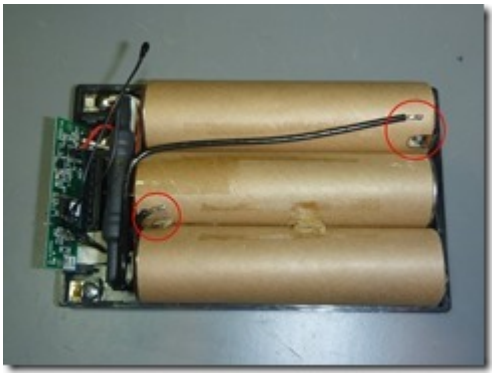
There are 6 single sub C cells that are joined in serial.

The six batteries are all wired in series (6 x 1,2V = 7,2 V).
The two batteries in series are 86mm long and have a diameter of 22,5mm.
So our replacement batteries have to be smaller than 42mm x 22,5mm (length x diameter) .

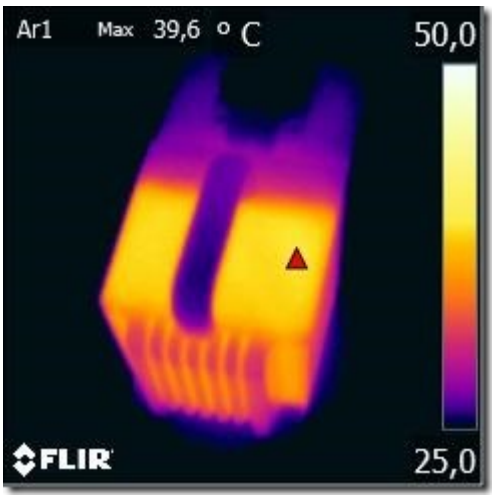
During one of the last RepairCafes I recognized that the transformer gets quite hot although nothing was plugged in. So I decided to do some further investigation.

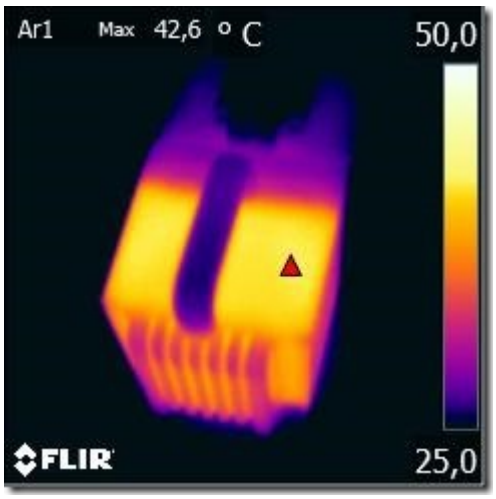
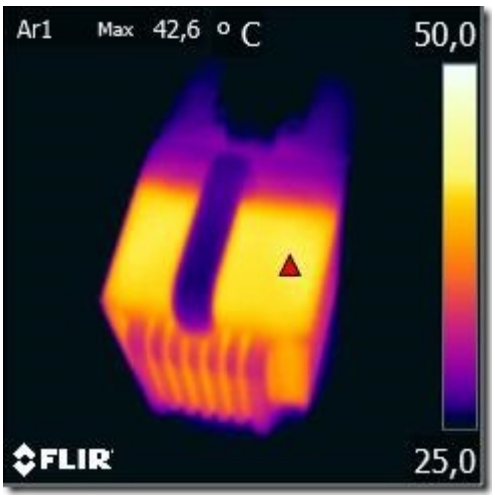
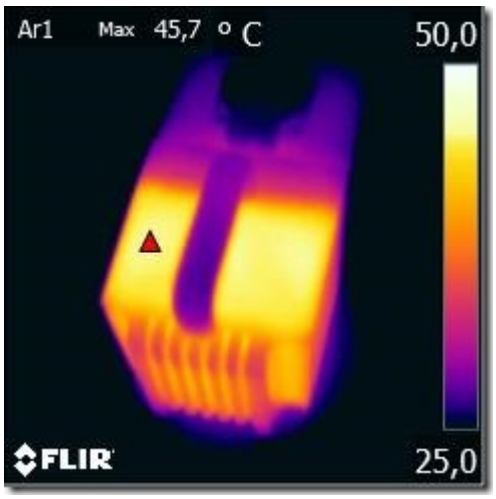
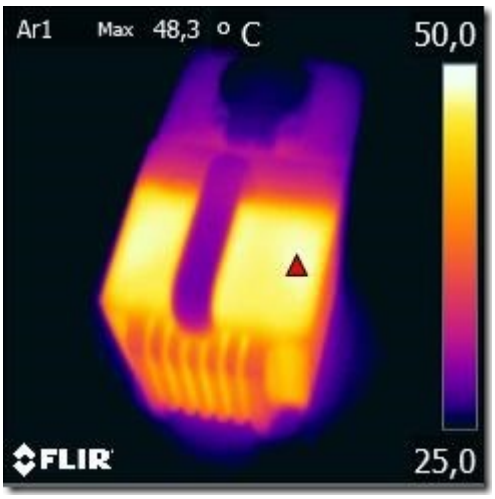
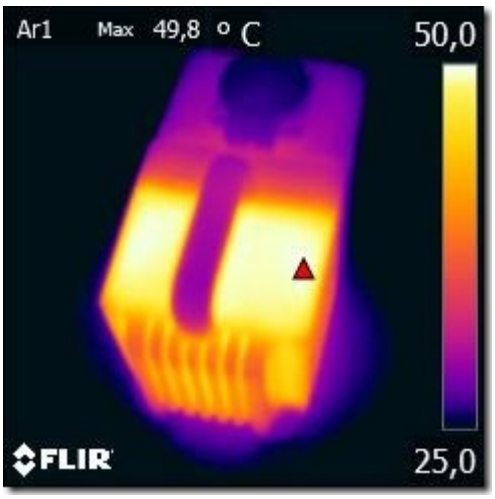
At home I plugged the unit into my Gossen Metrawatt Secutest SII+ and left it on for tree hours. In the picture below you can see a measurement of the power consumption. The power consumption was constant at 10W.

I also took infrared pictures every half hour to see how the temperature rises and what the maximum temperature is.

After tree hours the temperature was steady and didn’t increase any more. The room temperature was at about 24°C.

The Breve-Tufvassons PFS 250 doesn’t come with a power switch so you ether have to leave it on all the time or always pull the plug. Because I didn’t like neither I just installed a little switch in front of the unit. Now I can turn the transformer on when I have a device plugged in and the other

time the transformer is switched off and doesn’t get that hot.
