Elektra Bregenz GIF 3003 X dishwasher repair

Marantz PM7200 repair

Fluke 233 Display repair

Battery replacement on the Olympus BN-1

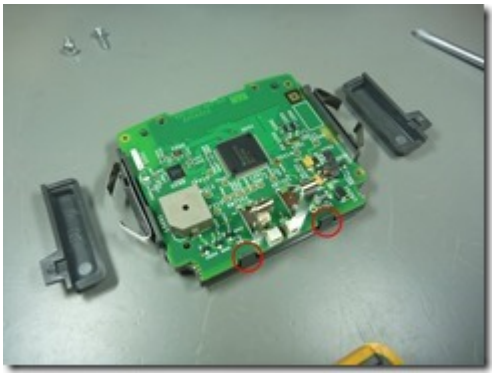
On two of the battery terminals there was a bit of corrosion.

Probably someone had left batteries to long in there. With a screwdriver and some alcohol prep pads the dirt came off really easy.

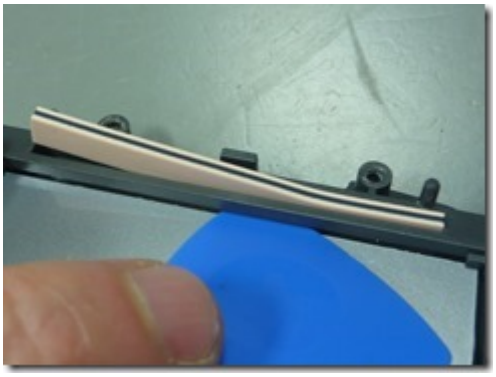
Next I took a closer look at the top unit. As you can see on the pictures the LCD Display was damaged. I ordered the replacement part from the Fluke distributor in Austria (Analog & Digital Messtechnik; http://www.kalibration.at/). The part number for the broken display is “LCD RDX (3385697)”.

After you removed the PCB from the housing the display is still connected to the PCB. You have to pry open the red marked plastic clips gently. The LCD assembly will then come off.

In order to change the LCD you have to lift it slightly up and slide it out in the directions of the buttons. At my unit the conductive rubber zebra stripe was stuck to the PCB. I used a pick to separate it carefully.

I installed the new LCD and reassembled everything again. The yellow rubber was a bit dirty. Alcohol prep pads work good to clean the rubber and let meter look like new.

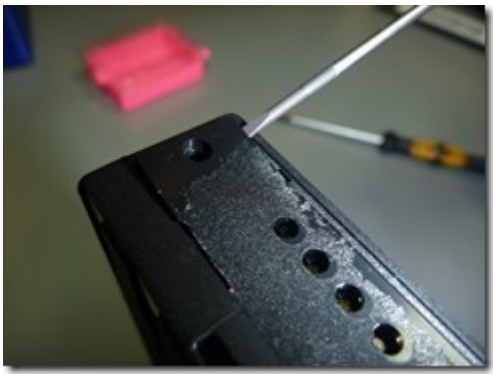
flash pack die. Olympus does not offer replacement Batteries. You have to throw away the whole battery pack and get a new one (which is about 200 €).

I thought that – before throwing it away – I give it a go and try to replace the batteries myself.

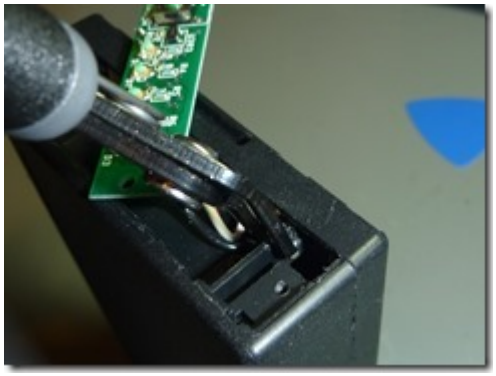
Olympus has molded the plastic case together. There is no easy way to get this apart.

The first step is to cut two small connections that are under the PCB. I used a side cutter to split them. Be careful not to cut the cables.

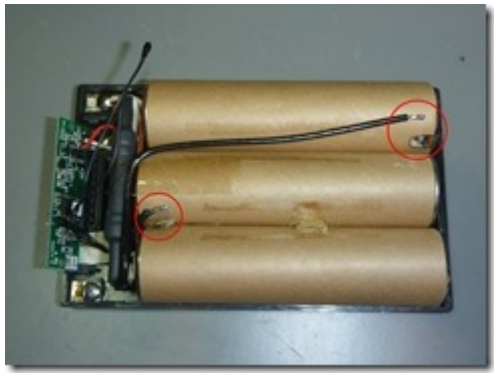
There are 6 single sub C cells that are joined in serial.

The six batteries are all wired in series (6 x 1,2V = 7,2 V).
The two batteries in series are 86mm long and have a diameter of 22,5mm.
So our replacement batteries have to be smaller than 42mm x 22,5mm (length x diameter) .

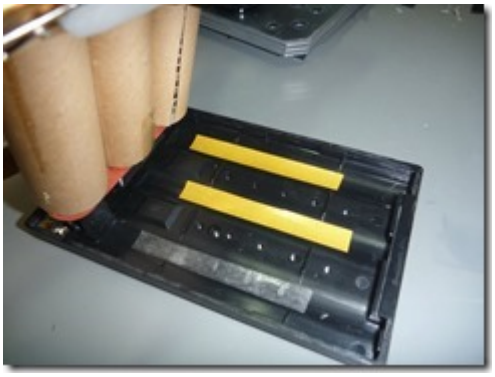
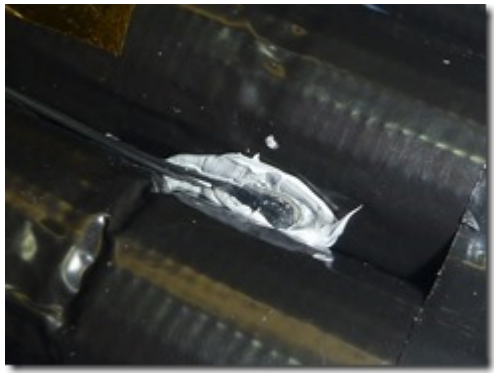
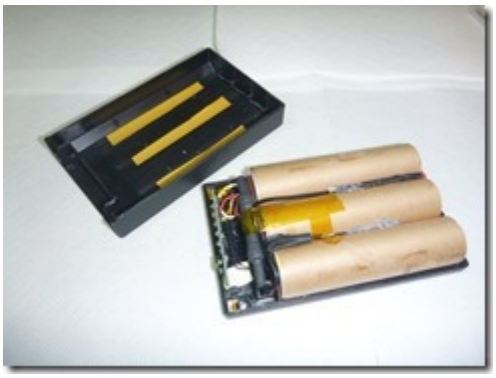
I thought about replacing the cells with eneloop; my tests showed that they provided to less peak current. The charging time for the flash would have been far to long.

In the electronic shop nearby they had battery packs where the single cell size matched. These packs are designed for RC usage. This means that they can provide a high peak current (perfect for our application). I took cells that had a higher capacity (3700mAh instead of 2600mAh);. Sadly there was no pack with the right alignment of the single cells so I had to align them. I reused the paper cover to isolate the new battery pack.

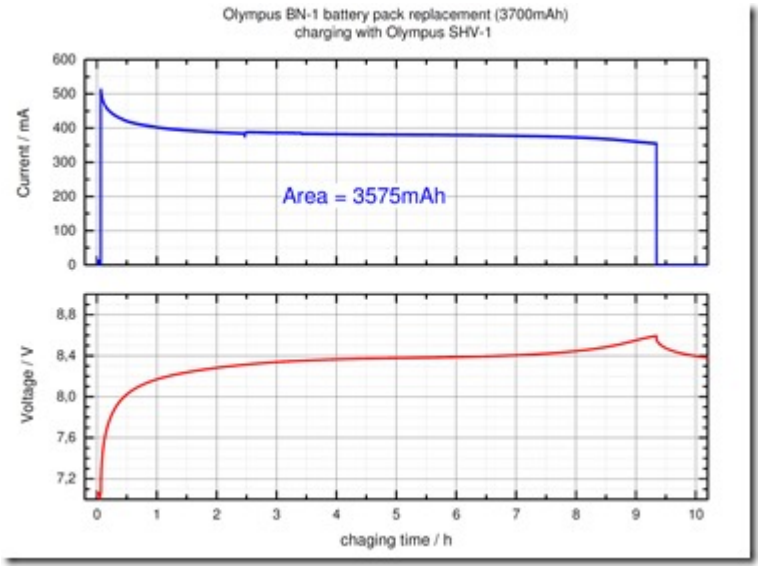
The charging worked just fine and took approximately 10 hours.

I monitored a full charging cycle with my bench top multimeter. The battery was charged with the Olympus charger (I had small copper strips to tap of the connections). I wanted to ensure that there are no problems (like a timeout) because of the increased capacity.
