## Elektra Bregenz GIF 3003 X dishwasher repair

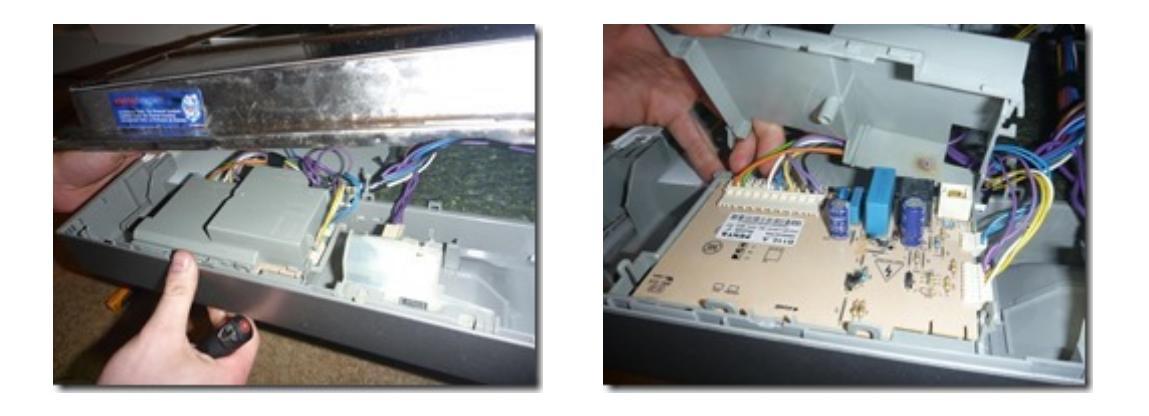
To remove the front, open the dishwasher and undo the screws that are on the inside of the front door. The two screws in the middle hold the wood faceplate. You don't need to take the faceplate off, but It makes the handling a bit easier (however to mount it back on it is good to have someone that helps you).

When you have removed all the screws, the front will split into two parts. The electronic is positioned at the front left corner (where the buttons are). It is enclosed in a separate plastic case that you can flip open after you remove the cables.

When you look on the second picture you may already can spot that there are some burning marks on the backside of the plastic cover right where the relay sits.

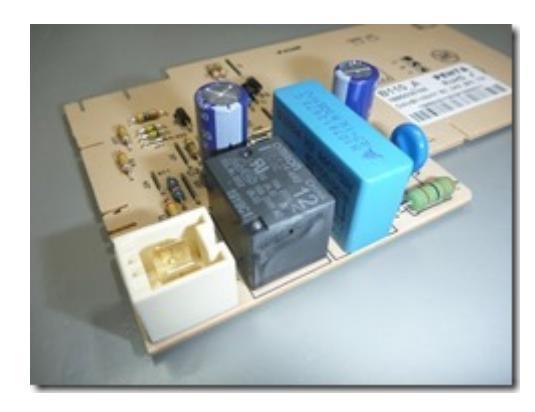
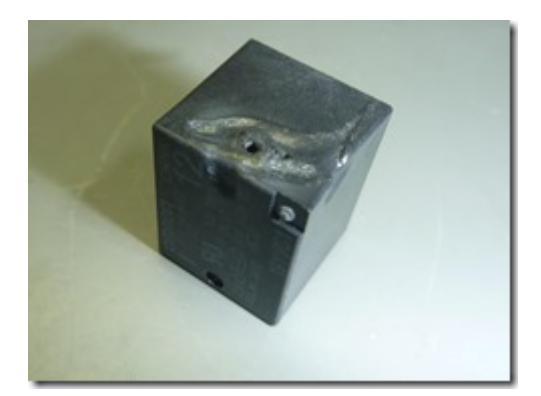
When I inspected the PCB closer, I saw that the relay, that switches the heating element, had a hole in it. Yes, a hole!

I have no idea what can cause a relay to look like this. I measured the heating element and the resistance was fine. So I

went ahead and replaced the relay ... but that didn't solve the initial problem. The dishwasher still switched itself off.

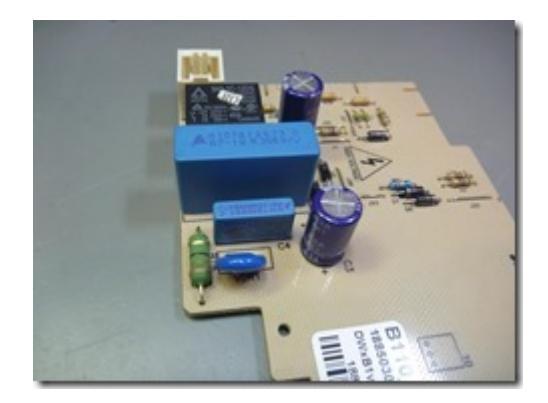
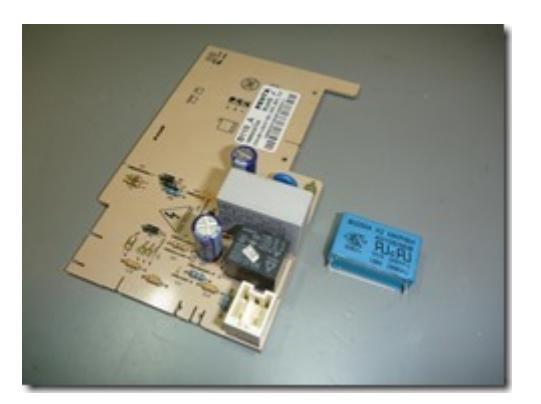
After some further measurements I found that the real cause of the problem was the power supply. This dishwasher uses a capacitive power supply (Wikipedia: https://en.wikipedia.org/wiki/Capacitive\_power\_supply). With the LCR meter it was quite easy to find that the 1 $\mu$ F capacitor had died. I think this is a little design flaw. Because of the placement of the control circuit, the capacitor is exposed to the inside temperature of the dishwasher (~ 65°C when the dishwasher is working). There is hardly any thermal insulation present. Fore sure this has reduced the lifetime of the capacitor significantly.

So the only thing to do was to replace the bad capacitor and everything was working again perfectly.
