# Elektra Bregenz GIF 3003 X dishwasher repair

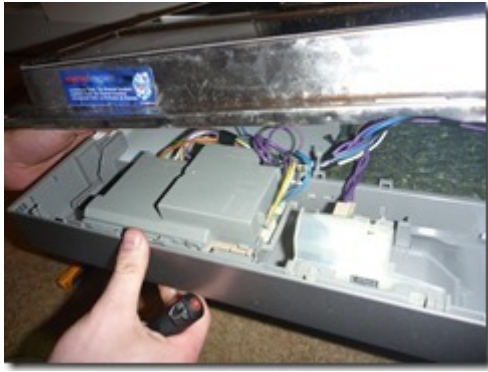
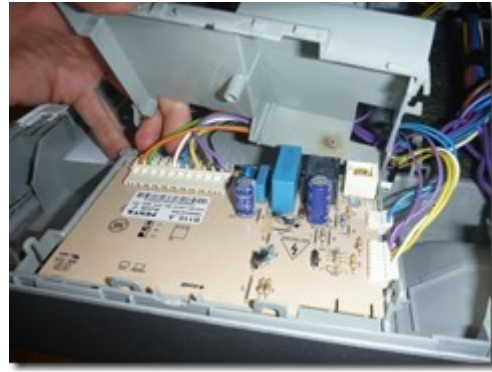
To remove the front, open the dishwasher and undo the screws that are on the inside of the front door. The two screws in the middle hold the wood faceplate. You don't need to take the faceplate off, but It makes the handling a bit easier (however to mount it back on it is good to have someone that helps you).

When you have removed all the screws, the front will split into two parts. The electronic is positioned at the front left corner (where the buttons are). It is enclosed in a separate plastic case that you can flip open after you remove the cables.

When you look on the second picture you may already can spot that there are some burning marks on the backside of the plastic cover right where the relay sits.

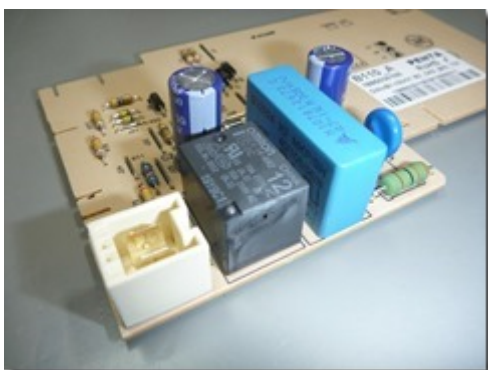
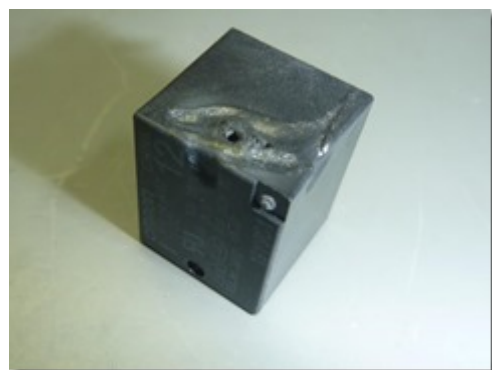
When I inspected the PCB closer, I saw that the relay, that switches the heating element, had a hole in it. Yes, a hole!

I have no idea what can cause a relay to look like this. I measured the heating element and the resistance was fine. So I

went ahead and replaced the relay ... but that didn't solve the initial problem. The dishwasher still switched itself off.

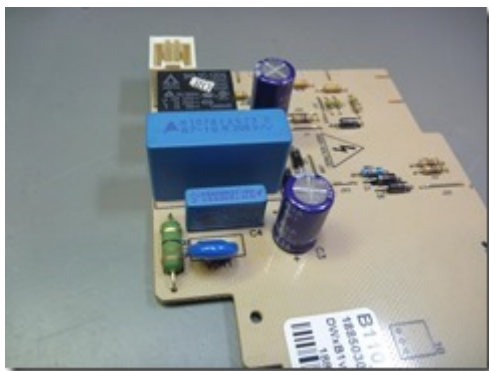
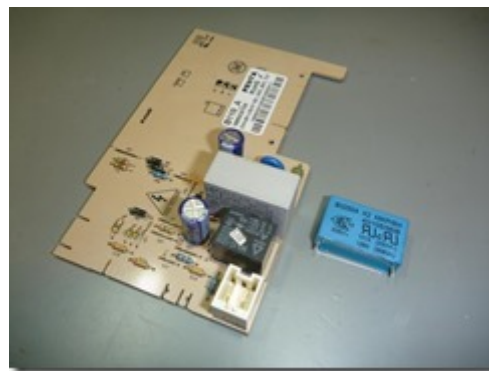
After some further measurements I found that the real cause of the problem was the power supply. This dishwasher uses a capacitive power supply (Wikipedia: [https://en.wikipedia.org/wiki/Capacitive\\_power\\_supply](https://en.wikipedia.org/wiki/Capacitive_power_supply)). With the LCR meter it was quite easy to find that the 1 $\mu$ F capacitor had died. I think this is a little design flaw. Because of the placement of the control circuit, the capacitor is exposed to the inside temperature of the dishwasher (~ 65°C when the dishwasher is working). There is hardly any thermal insulation present. Fore sure this has reduced the lifetime of the capacitor significantly.

So the only thing to do was to replace the bad capacitor and everything was working again perfectly.
